# **FAILURE STUDY OF RUBBER-CORD FLEXIBLE COUPLINGS AND THEIR MOUNTING BOLTS**

Summary of the Doctoral Thesis

**RIGA TECHNICAL UNIVERSITY**

Institute of Transport

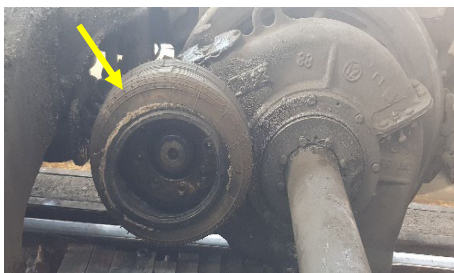
Fig. 1.3. Example of rubber-cord coupling layer rupture.

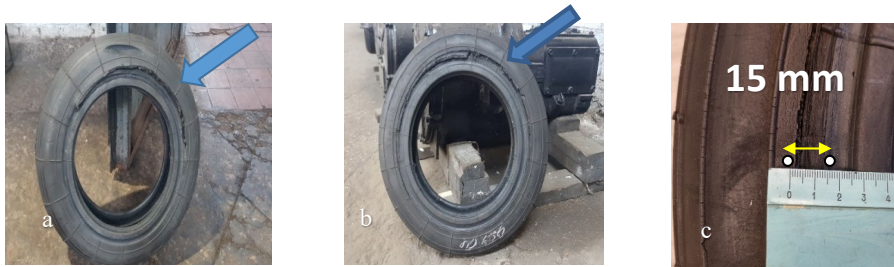
There were 21 cases of coupling damage in the period from September 2019 to 31 December 2021. Examples of the side surface disintegration of the rubber-cord coupling are shown in Fig. 3.1.

Fig. 3.1. Examples of the side surface disintegration of a rubber-cord coupling: a – sample 1; b – sample 2; c – determining the destruction zone sample 2.

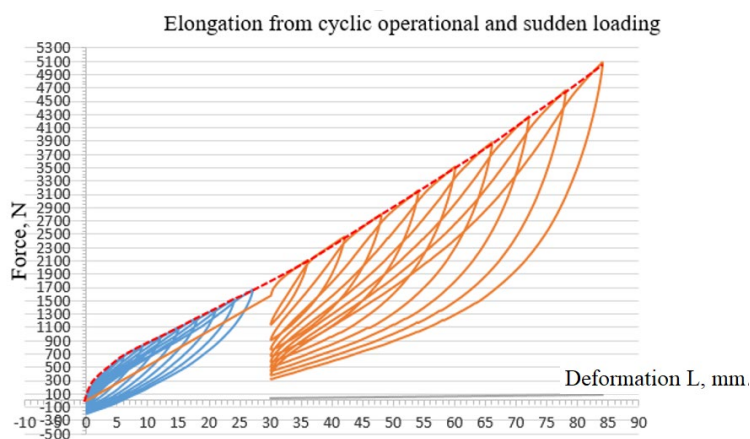
Fig. 3.5. Deformation graph of Fragments 2 and 5, depending on operational and sudden cyclic loads.

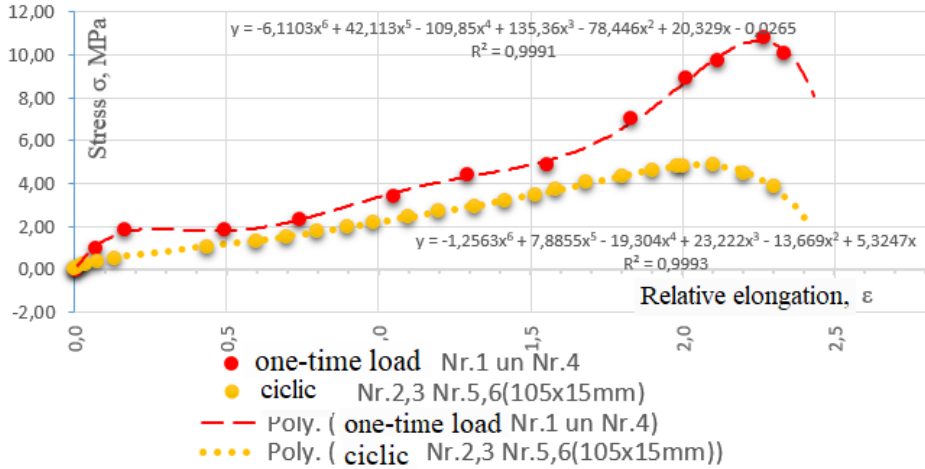
A comparison of the results of the one-way stretching test of coupling Fragments 1 and 4 at one-time stretching ( $R^2 = 0.9991$ ) and coupling Fragments 2 and 5 at operation and extreme cyclic loads ( $R^2 = 0.9995$ ) until disintegration are shown in Fig. 3.6.

Fig. 3.6. Comparison of unilaterial tensile test results.

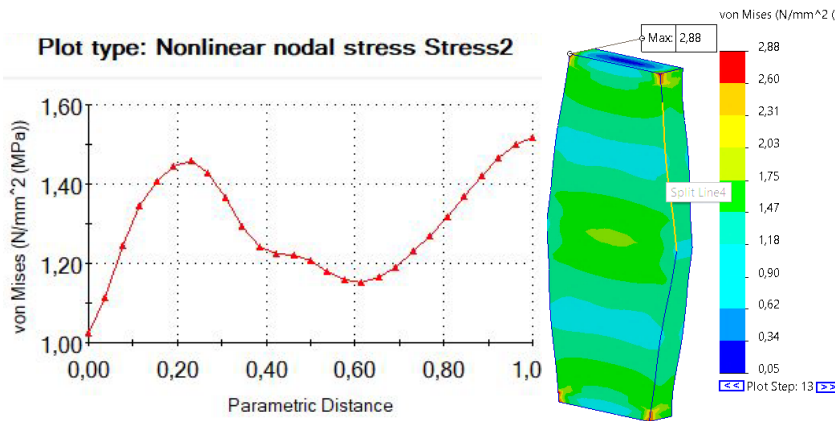
The stress distribution on the vertical edge of the fragment of the superelastic material model according to the Mooney–Rivlin method is shown in Fig. 3.10.

Fig. 3.10. Edge response from the anchorage to the mid-section of the 100 mm long fragment.

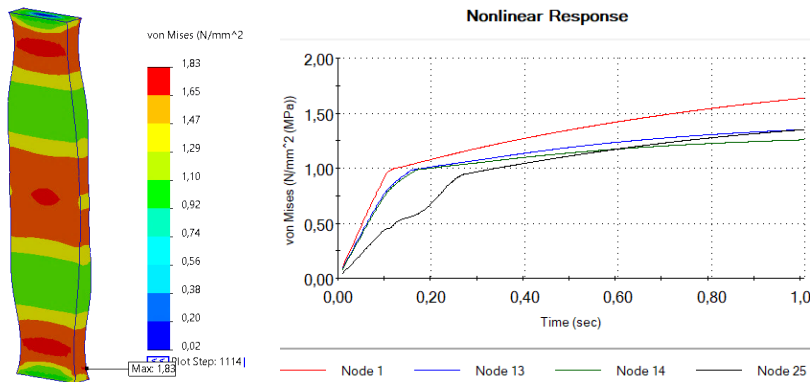
Fig. 3.14. Node response of the nonlinear model (sample length 220 mm).

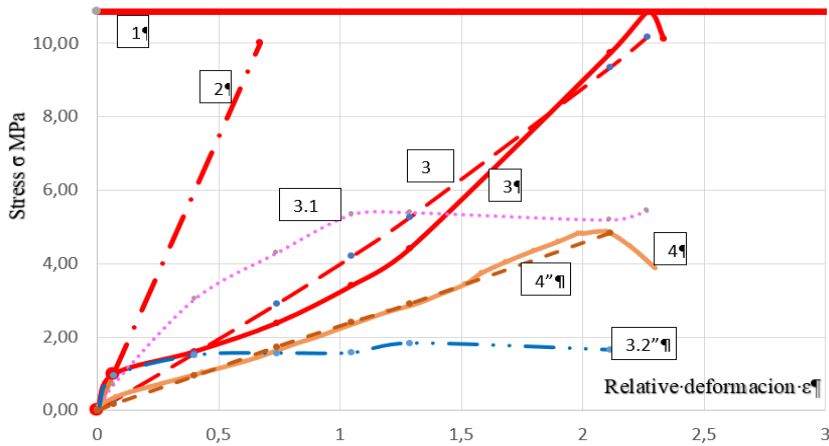
Fig. 3.15. Results of modeling the stretching of fragments of the coupling shell by various methods: 1 – ultimate strength (10.86 MPa); 2 – modulus of elasticity 14.73 MPa; 3 – experimental results – single stretching to rupture; 3'' – results using the Mooney–Rivlin method for two constants; 3.1'' – results using the Blatz method; 3.2'' – results using the nonlinear elastic method; 4 – results of the experiment – cyclic tension to failure; 4'' – results using the Mooney–Rivlin method in two constants by modifying the mesh of the model and the dimensions of the finite elements.

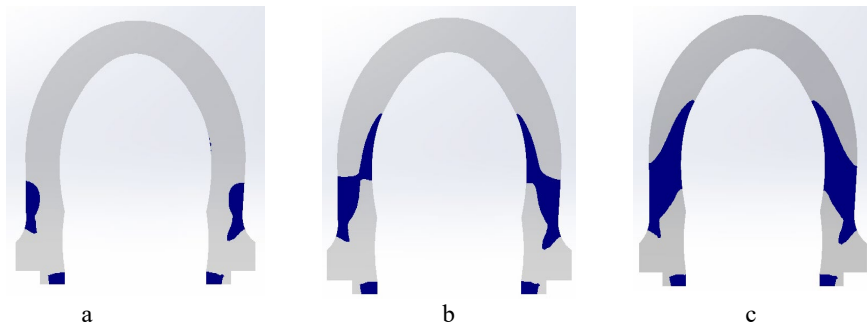
Fig. 3.20. Distribution of stresses on the surface of the coupling shell at idle:  
 a – 1521 rpm (100 km/h); b – 1673 rpm (110 km/h); c – 1825 rpm (120 km/h).

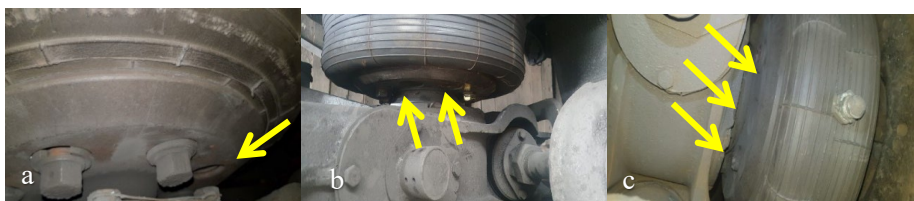
The bolts used for fastening the rubber-cord coupling in rolling stock and especially in electric trains are repeatedly exposed to periodically changing loads over time and subjected to impulse, high-frequency, periodic and non-periodic, as well as variable amplitude and impact loads. As a result of exposure to repeated variable shock loads, the strength of the bolt material decreases and M24 rubber-cord coupling bolts may be prone to disintegration [13]–[17]. Examples of the breakage of M24 rubber-cord coupling bolts are shown in Fig. 3.27.

Fig. 3.27. Rubber-cord coupling degradation patterns:  
a – fracture of the 1st bolt; b – two bolt fractures; c – three bolt fractures.

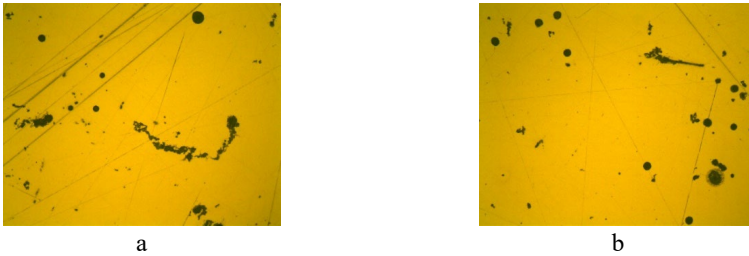
Metallographic analysis of bolts subjected to impact loads of 20 000 N and 100 000 N is shown in Figs. 3.32 and 3.33.

Fig. 3.32. Metallographic analysis after 360 impacts with a force of 20 000 N, magnification –  $\times 200$ :

a – Sample 15; b – Sample 16.

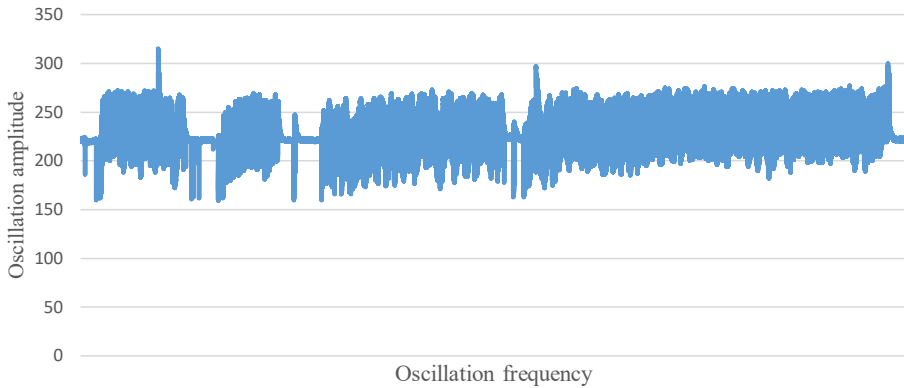
Fig. 3.35. Shock vibration load graph for one working day.

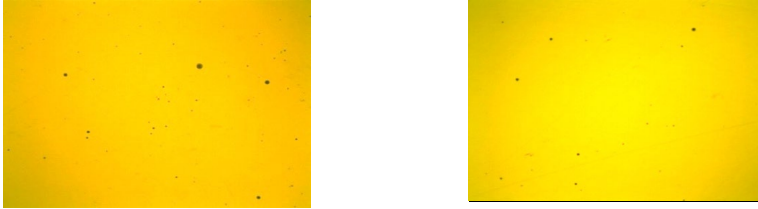
The results of metallographic analysis of bolt Samples 21 and 26 are shown in Figs. 3.36 and 3.37, magnification –  $\times 100$ .

Fig. 3.36. Metallographic analysis of bolt Sample 21, mileage 12 882 km.

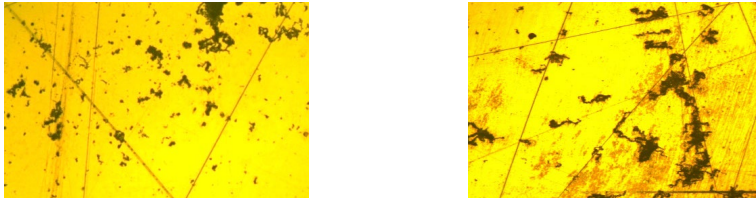
Fig. 3.37. Metallographic analysis of bolt Sample 26, mileage 79 906 km.
