RIGA TECHNICAL  
UNIVERSITY

**METHODOLOGY TO PROVIDE A CONSERVATION  
MICROCLIMATE IN THE HISTORICAL RELIGIOUS  
BUILDINGS**

Doctoral Thesis

Faculty of Civil and Mechanical Engineering  
Institute of Sustainable Building Materials and Engineering Systems

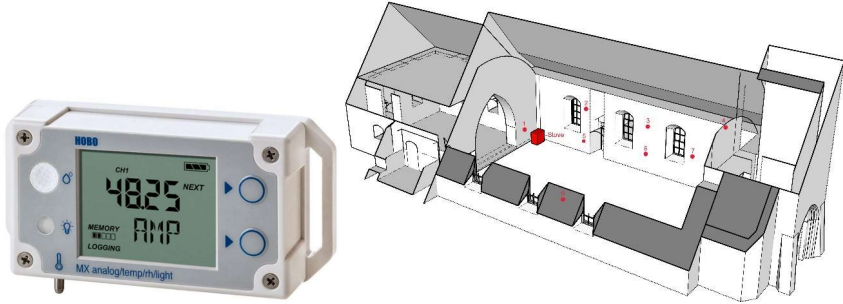
Temp/RH/Light/Ext-Temp Kit (Fig. 3.2) at 30-minute intervals, with a measuring accuracy of  $\pm 2.5\%$  for relative humidity and  $\pm 0.2\text{ }^\circ\text{C}$  for temperature. These measurements were part of the studies presented in Papers III and V.

Fig. 3.2. Measuring instrument and location example in Krimulda Church [23].

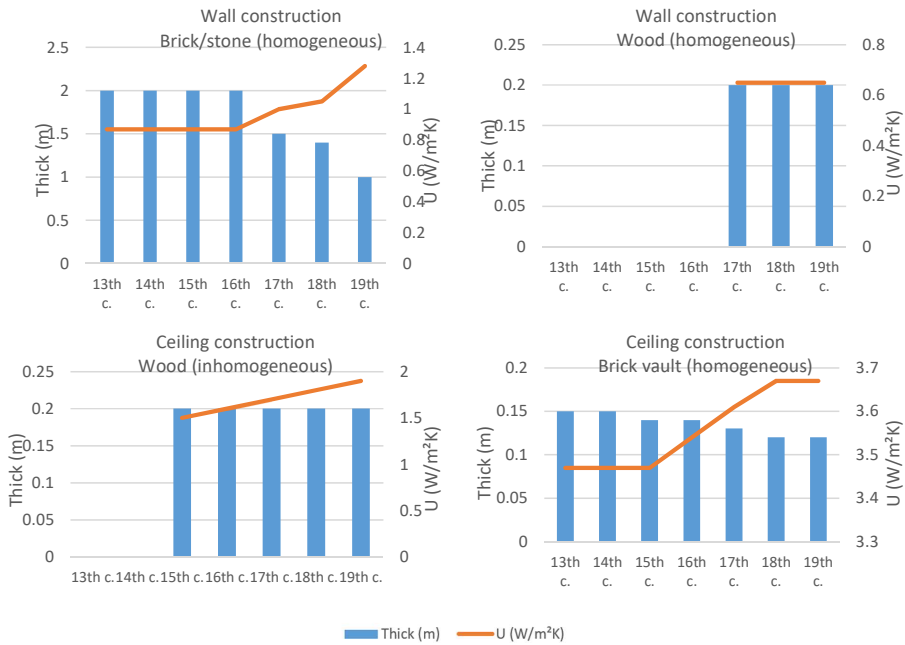
The structural analysis of these churches revealed that wall thickness decreases with each subsequent century, from 1.5–2.0 m in the 13th–16th centuries to 0.8–1.0 m in the 19th century. The thermal conductivity coefficient ( $\lambda$ ) of masonry walls remained around 0.87 W/m·K throughout this period, while ceiling materials varied, resulting in a  $\lambda$  range from 0.1 W/m·K to 0.8 W/m·K, depending on whether the material was a brick vault, wooden vault, or straight wooden construction (Fig. 3.4).

Fig. 3.4. Types, dimensions and thermal transmittance U of church constructions.

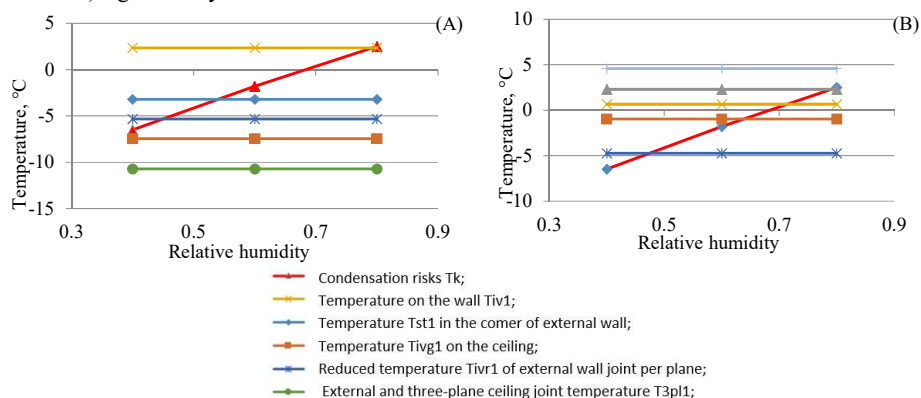
The results indicate that wooden churches generally pose a lower risk of condensation, especially when the RH stays below 60 %. However, elevated RH levels (e.g., 82 % in Turaida Church) significantly increase the risk.

Fig. 3.5. Calculated wall and ceiling surface temperatures with indoor air temperature 6 °C: A – in brick churches, B – in wooden churches.

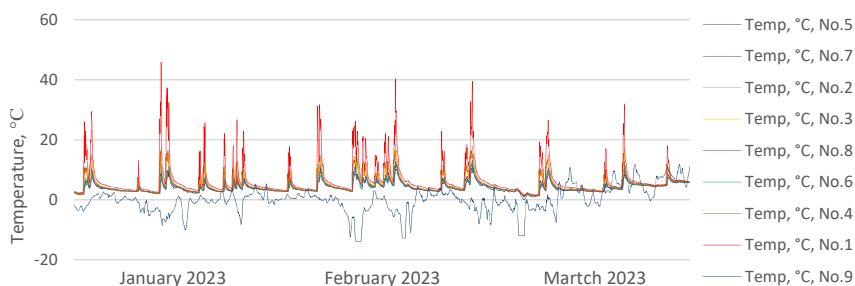
For the heating strategy of a religious building, opting for a single heat source for the entire structure, as is the case with the Krimulda Church, can result in an uneven temperature distribution within the premises. Consequently, both the internal surface of its building envelope and the surfaces of various valuable items/interior details can reach the dew point temperature. We can conclude that irregular heating strategies cause significant temperature fluctuations in the indoor air and on the surfaces of the building (e.g., walls, ceiling, floor, interior items), leading to moisture condensation on various surfaces (see Fig. 3.6). Therefore, this heating strategy cannot be defined as a heating system providing a preserving microclimate.

Fig. 3.6. Temperatures in the Krimulda Church.

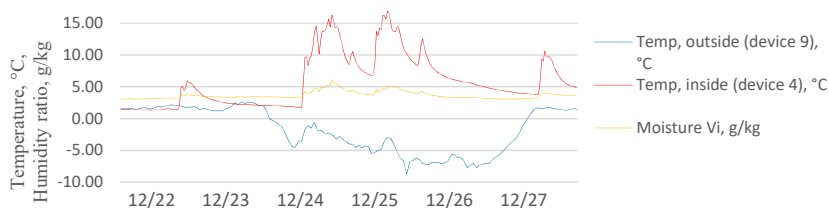
The results of indoor air parameter measurements and calculations in the Krimulda Church indicate that the moisture vapours from the building structures (including the building envelope and interior details) constitute up to 2 g/kg (Fig. 3.7).

Fig. 3.7. Outdoor and inside moisture and temperature in the Krimulda Church on the balcony between 12/22/2022 and 12/28/2022.

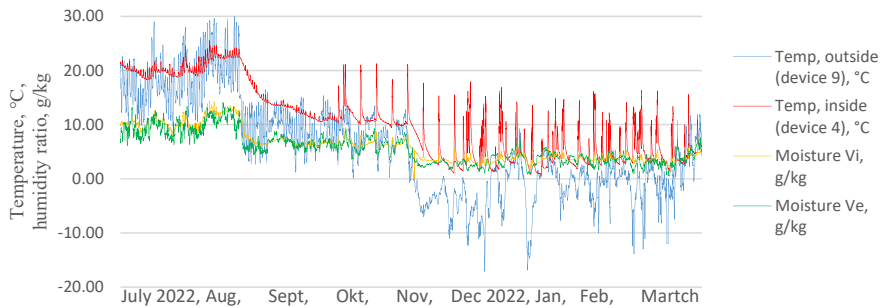
A significant influx of visitors during the heating season, along with the rapid increase in indoor temperatures resulting from a heating device, can lead to condensation risks. Potential condensation risks can be prevented either by ensuring a constant minimum indoor air temperature of 7 °C or by means of air-drying methods to reduce the indoor humidity level from 6.1 g/kg to 4.5 g/kg.

Fig. 3.8. Outdoor and inside humidity and temperature in the Krimulda Church on the balcony.

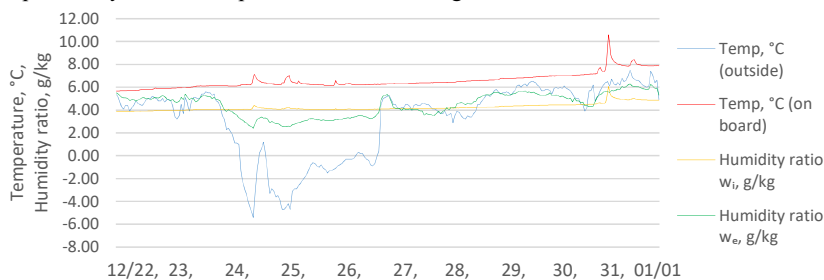
Increasing the indoor temperature with a heating element by 3 °C (without visitors of the building), one can detect an increase in indoor air humidity ratio by 1.1 g/kg (Fig. 3.9), which is explained by moisture vapours from the building's structures and interior items.

Fig. 3.9. Outdoor and inside moisture and temperature in Liepaja St. Trinity Cathedral on the board between 12/22/2022 and 01/02/2023.

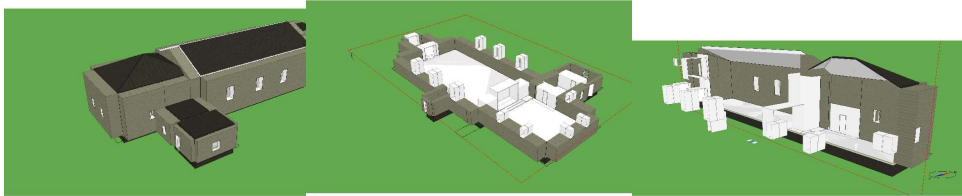
To determine the surface temperatures of the building's enclosing structures and the direction of air condition changes in the space for the four objects studied in Papers III and V – Turaida Church (Fig. 4.4), Krimulda Church (Fig. 4.1), Riga Jesus Church (Fig. 4.3), and Liepāja Holy Trinity Cathedral (Fig. 4.2) – simulation models are created using the IDA ICE

Fig. 4.1. IDA model of Krimulda Church.

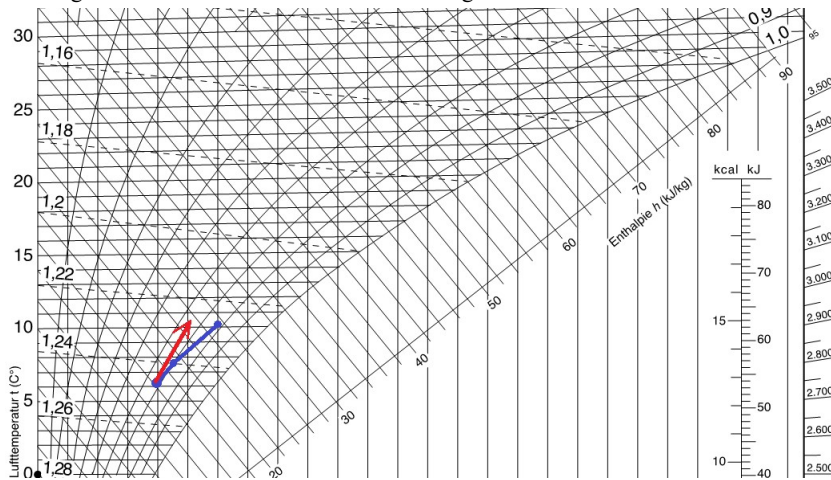
The theoretical calculation of the air state change direction, differing from the measured value, indicates that there is indeed a higher increase in moisture content in the room, confirming moisture condensation from the building's structures.

Fig. 4.8. Angular coefficient of process changes of air parameters on Molier diagram (red –  $\epsilon$ , blue – measurement) in the Liepaja St.Trinity Chatedral

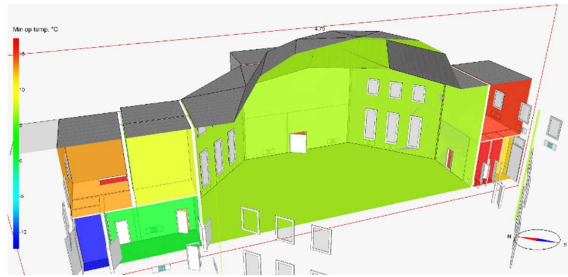
From Fig. 4.9, it is observed that the internal surface temperatures of the enclosing structures in the large hall are above 0 °C. To assess potential risks, critical load moments are examined by reviewing surface temperatures over a one-year period (Fig. 4.10).

Fig. 4.9. Temperatures of Riga Jesus Church's inside surfaces.

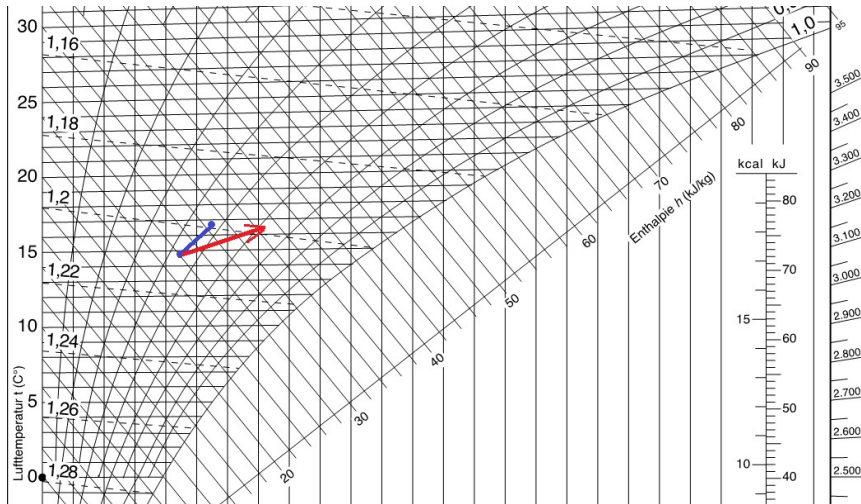
From the diagram, it is observed that there is a discrepancy between the calculated and measured values, suggesting either a higher actual heat input or lower air moisture content, possibly due to significant outdoor air infiltration. Comparing the measured data from this church with measurements from four other churches, it is evident that this church exhibits the highest temperature during the cold period. This higher internal and external air temperature fluctuation increases the rate of outdoor air infiltration, as confirmed by the excess moisture calculations detailed in Paper V.

Fig. 4.11. Angular coefficient of process changes of air parameters on Mollier diagram (red –  $\epsilon$ , blue – measurement) in the Riga Jesus Church.

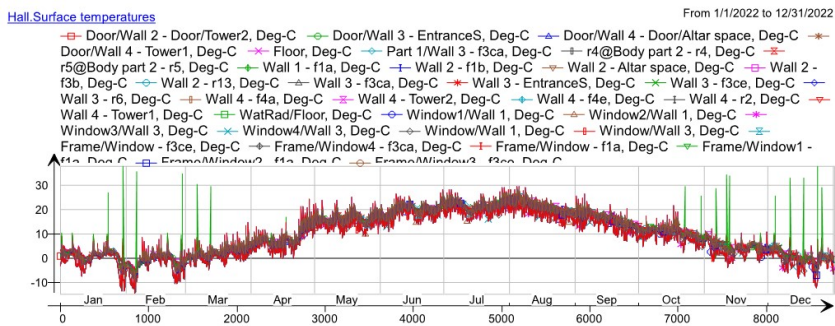
Fig. 4.13. Temperatures of Krimulda Church’s inside surfaces.

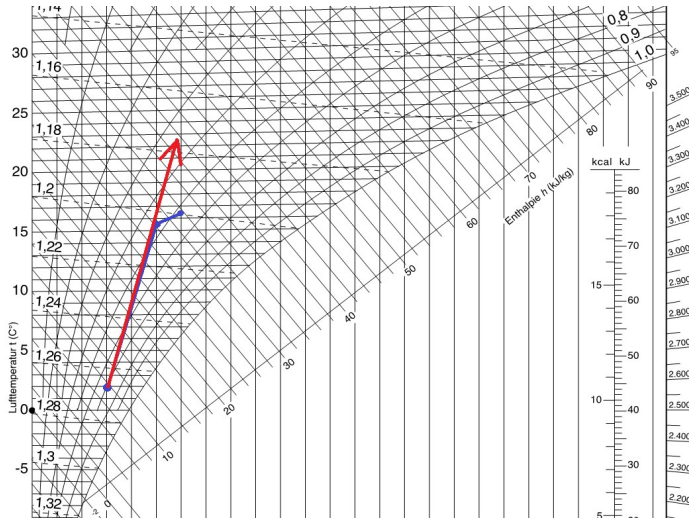
In buildings like Krimulda Church and Liepaja Cathedral, where significant thermal mass in the construction is employed, moisture evaporation from the building materials can significantly affect the indoor air conditions. This moisture evaporation process is not typically accounted for in simplified energy simulation models like IDA ICE, leading to discrepancies between simulated and measured data, especially in terms of humidity-related parameters. Therefore, when analysing such buildings, it is crucial to consider the actual physical properties and behaviours of the building materials and their interaction with the indoor environment.

Fig. 4.14. Angular coefficient of process changes of air parameters on Molier diagram (red –  $\epsilon$ , blue – measurement) in the Krimulda Church.

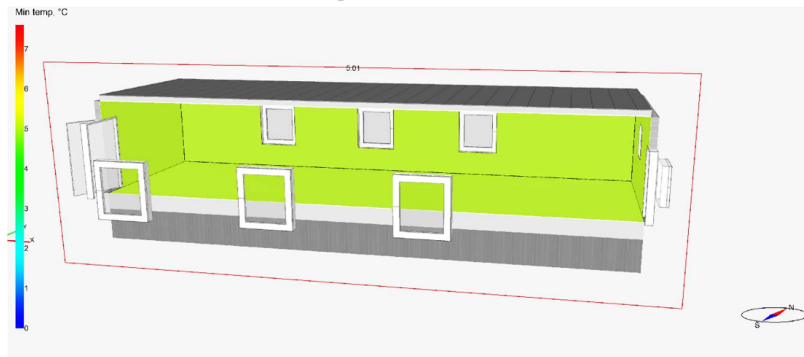
Fig. 4.15. Temperature of Turaida Church’s inside surfaces.

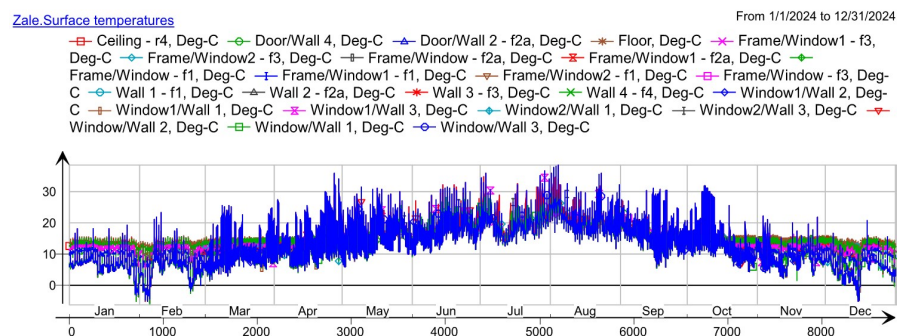
Figure 4.16 provides insights into the variations in surface temperatures throughout the year, highlighting critical periods where temperatures approach or drop below certain thresholds. This analysis helps in identifying potential risks such as condensation or discomfort due to low surface temperatures, especially in historical buildings like Turaida Church, where maintaining optimal indoor conditions is crucial for preservation and comfort.

Fig. 4.16. Temperature of Turaida Church's inside surfaces.

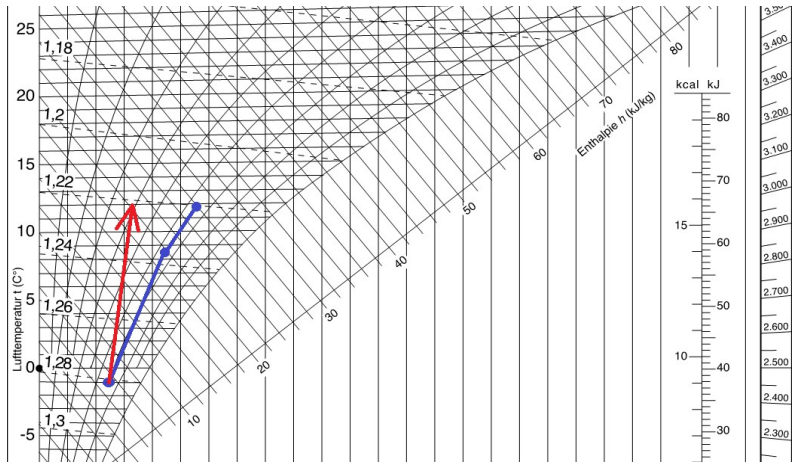
Measured discrepancies between calculated and actual indoor air state changes highlight the complexity of maintaining consistent environmental conditions in historical buildings, where thermal mass and moisture dynamics play crucial roles. Accurate modelling requires considering these dynamic interactions to better predict and manage indoor climate variations effectively.

Fig. 4.17. Angular coefficient of process changes of air parameters on Molier diagram (red –  $\epsilon$ , blue – measurement) in the Turaida Church.

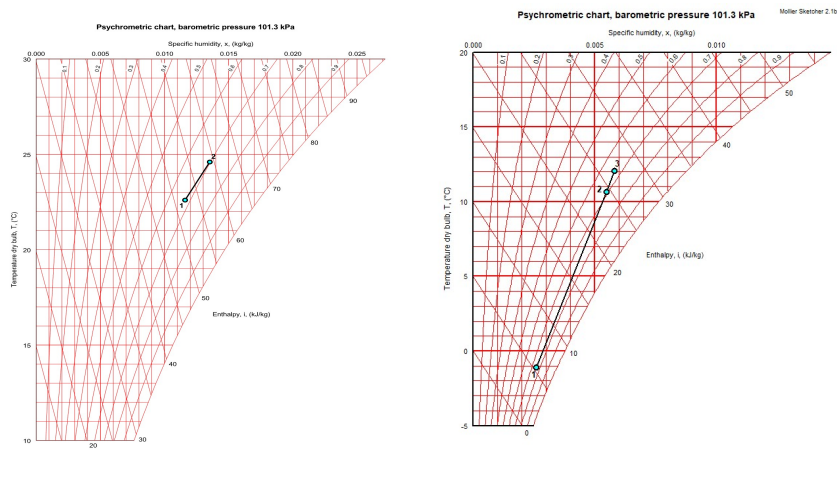
Fig. 5.3. Turaida Church – h-x diagram: A – 27 August 2022; B – 12 December 2022 (1 – 21/12/2022 14:00; 2 – 24/12/2022 15:00; 3 – 24/12/2022 16:00).

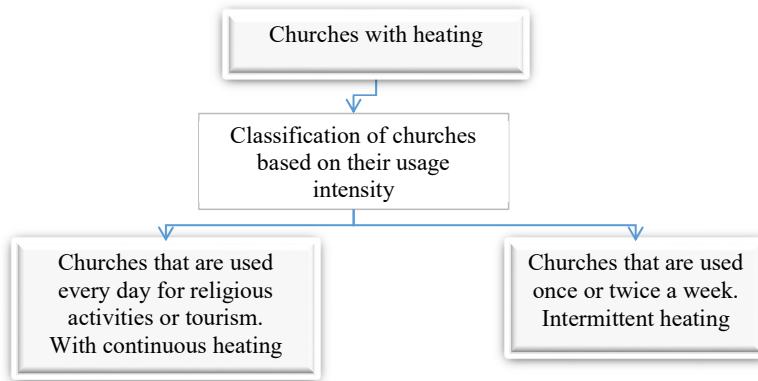
Fig. 5.6. Classification of heating strategies in heated churches according to usage intensity.

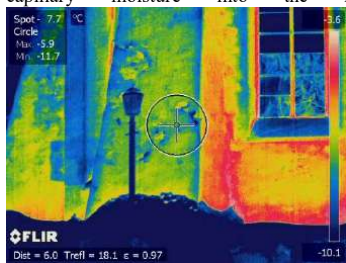
**Figure 4.** Wall of Cesis Church from outside

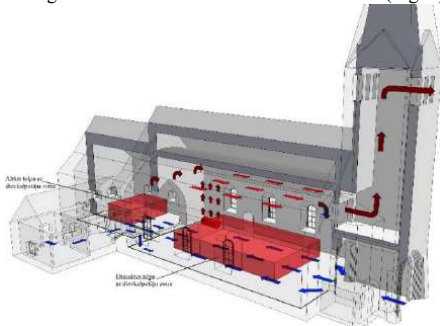
Figure 12. Air flow scheme of Krimulda Church

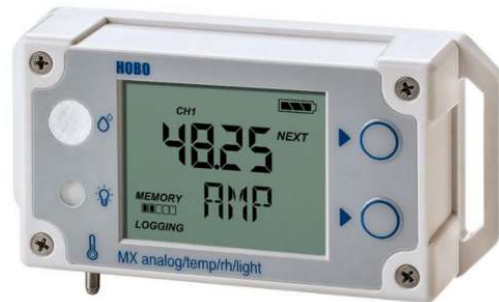
Figure 1. HOBO MX Temp/RH/Light/Ext-Temp Kit.

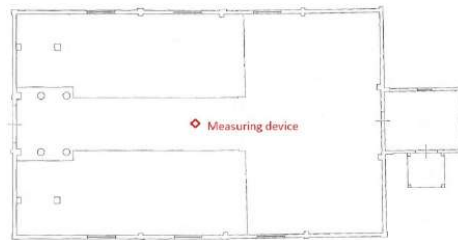
**Figure 6.** Turaida church plan with the location of the measuring device.

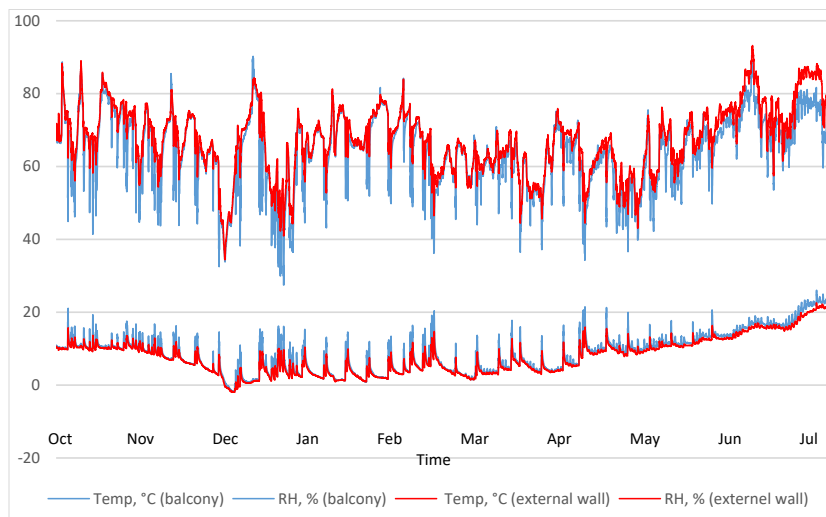
**Figure 7.** Humidity and temperature measurements in Krimulda church.

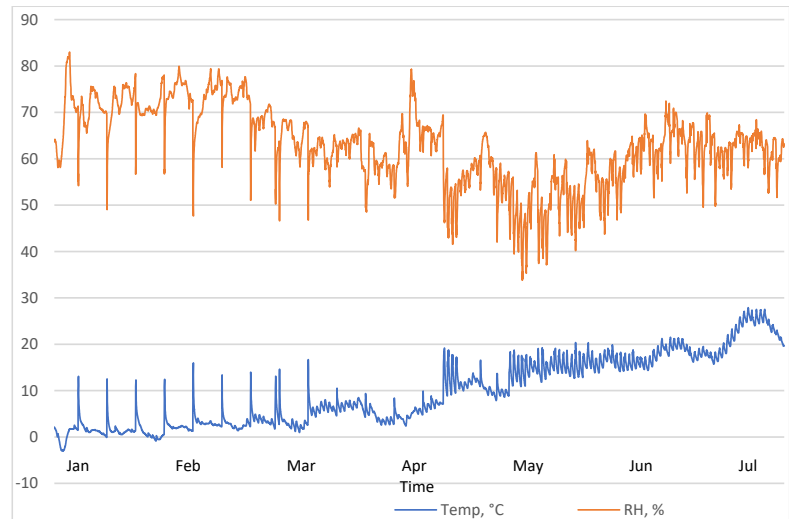
**Figure 8.** Humidity and temperature measurements in Turaida church.

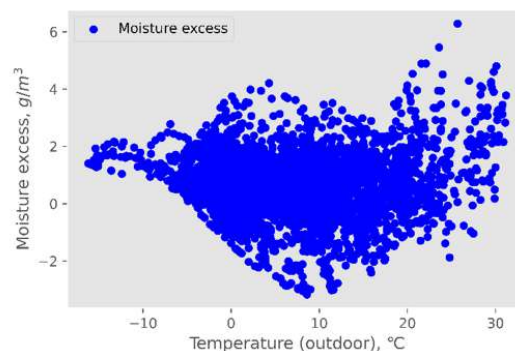
**Figure 9.** Moisture excess in Krimulda church on the balcony.

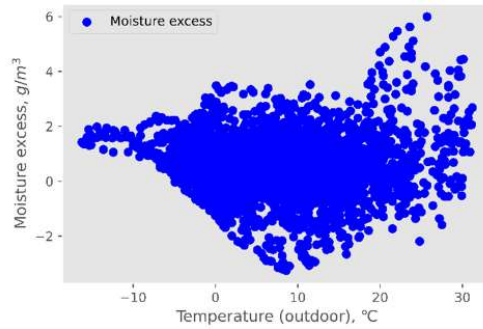
Figure 10. Moisture excess in Turaida church on the lamp.

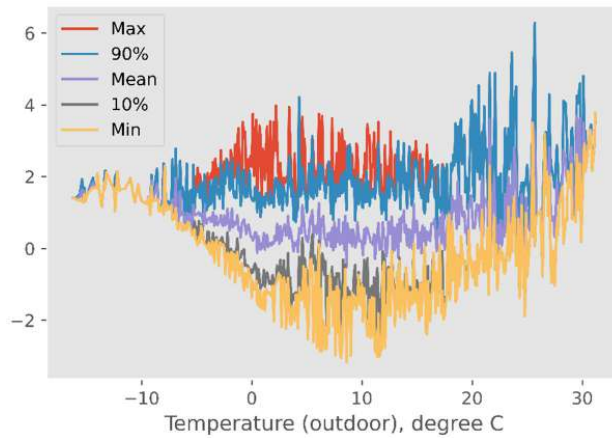
Figure 11. Average moisture excess in Krimulda church on the balcony.

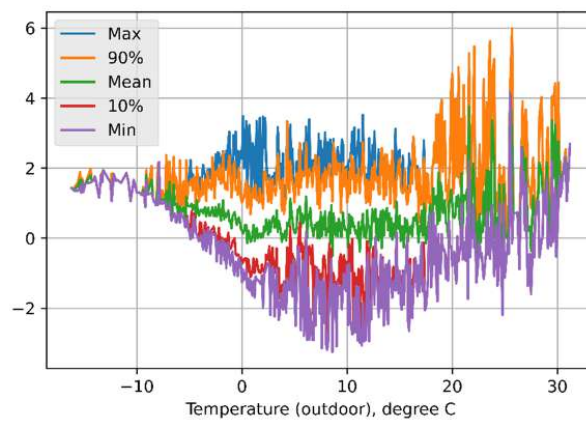
Figure 12. Average, oisture excess in Krimulda church on the external wall.

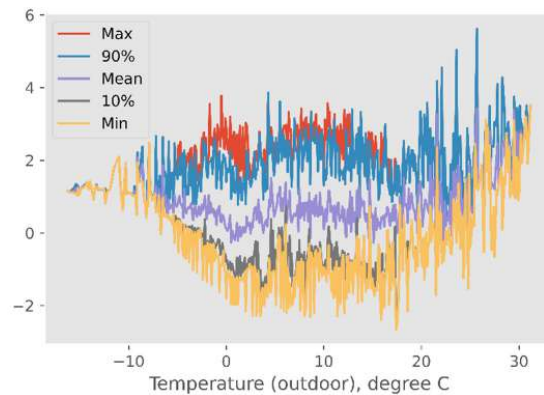
**Figure 13.** Average moisture excess in Turaida church on the lamp.

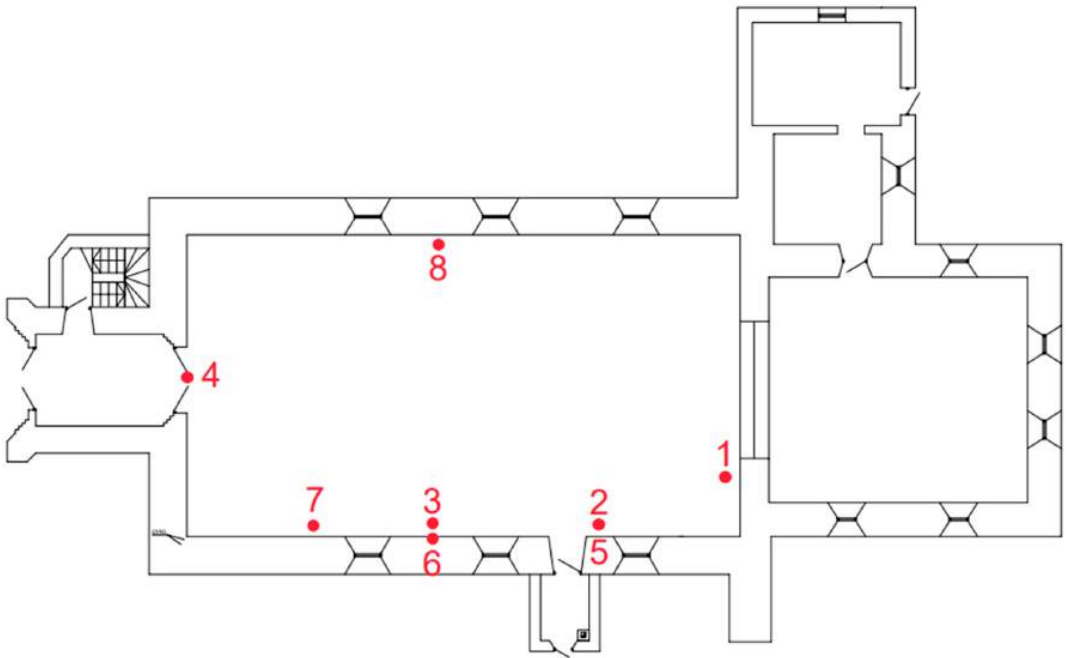
**Figure 4.** Layout of the Krimulda Church with the installed measuring devices (where 1–8: numbers of measuring devices).

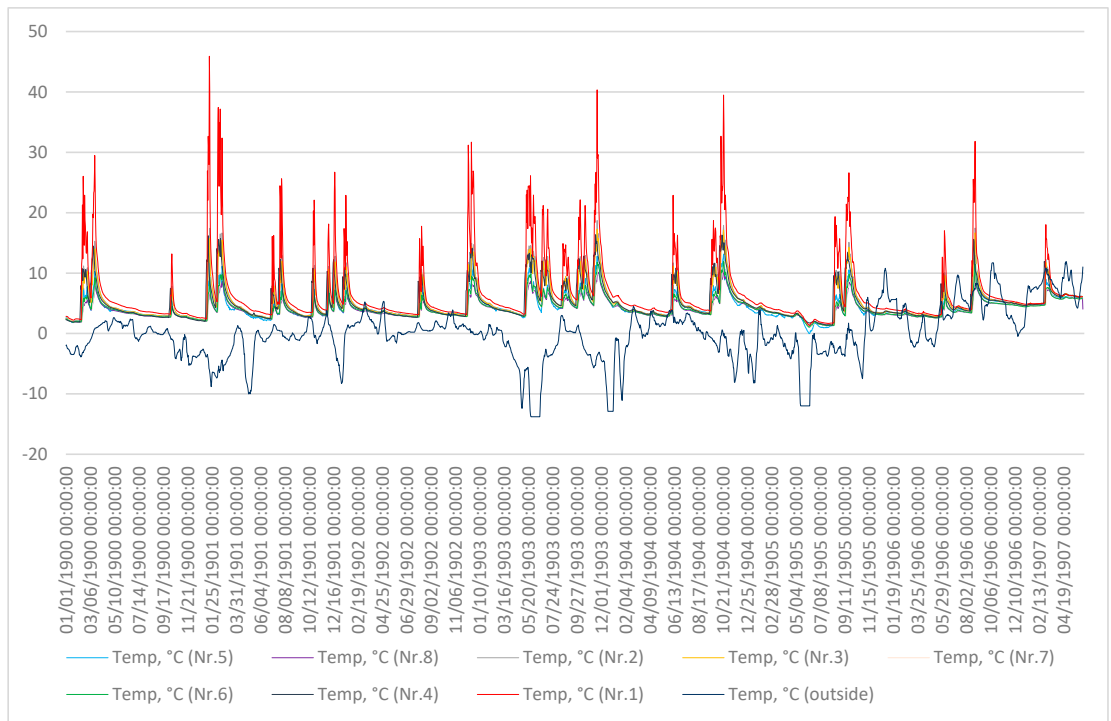
**Figure 7.** Temperatures in the Krimulda Church.

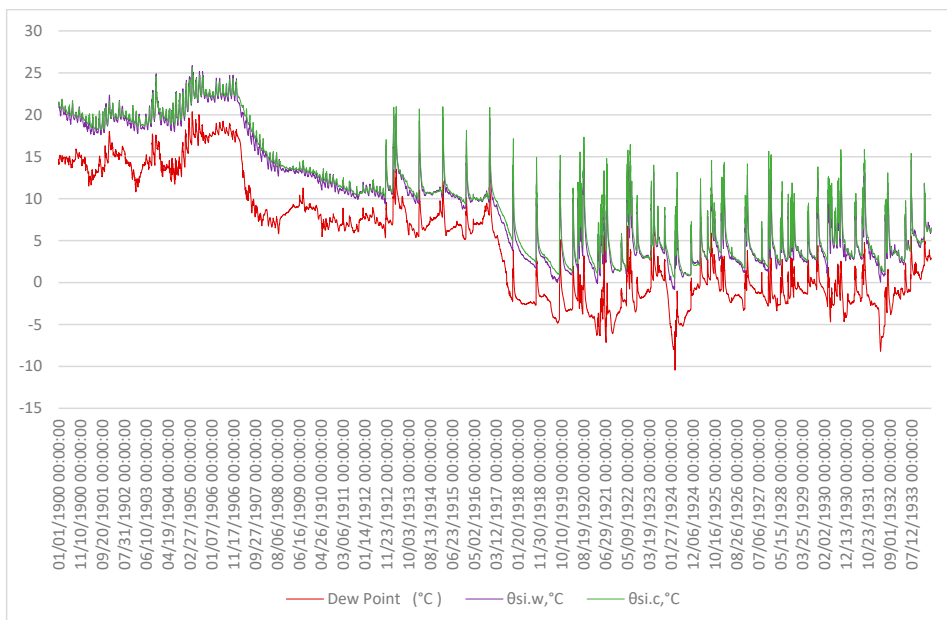
Figure 11. The calculated temperatures in the wall and ceiling surface, as well as the dew point.

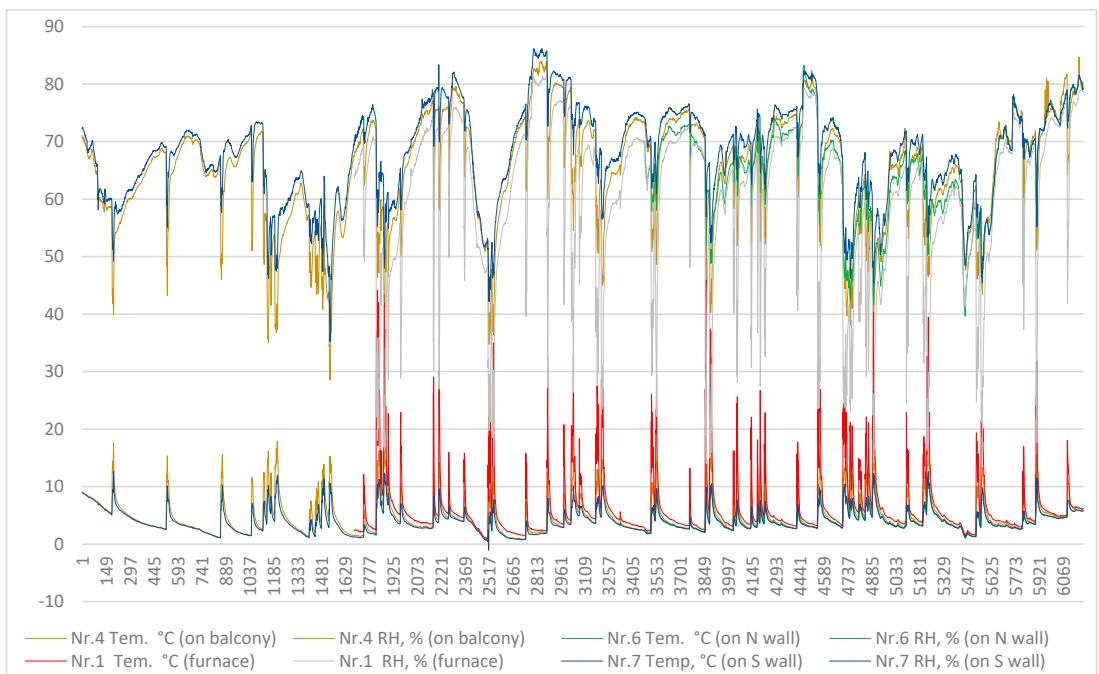
**Figure 12.** RH and temperature in the Krimulda Church between 11/16/2022 and 25/03/2023.

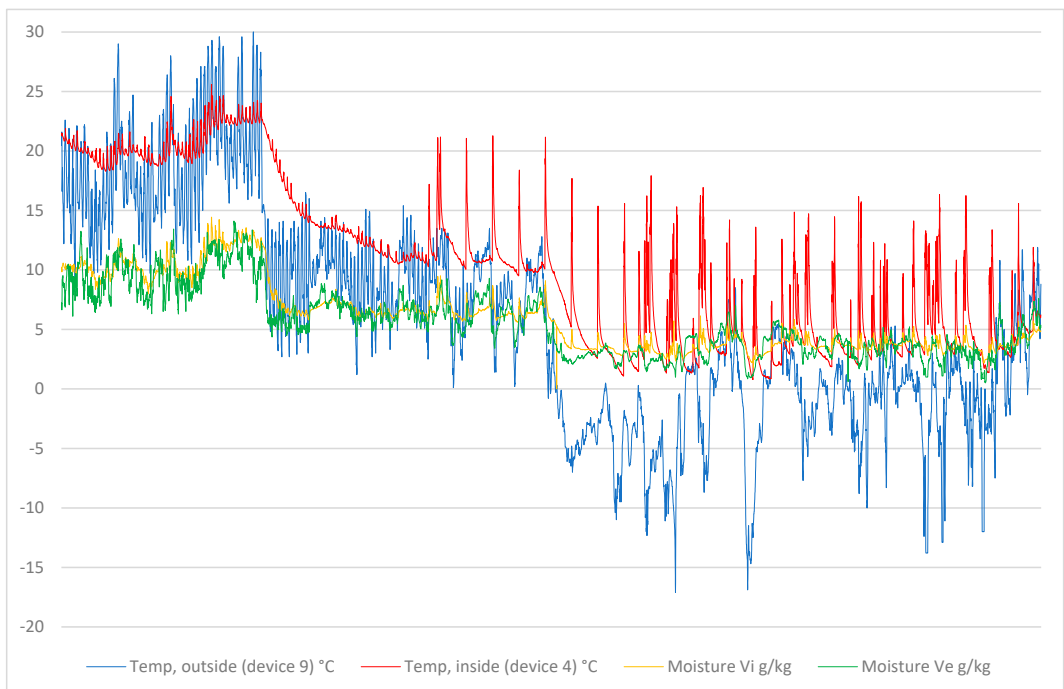
**Figure 13.** Outdoor (device 9) and indoor moisture and temperature in the Krimulda Church on the balcony (device 4) between 12/22/2022 and 12/28/2022.

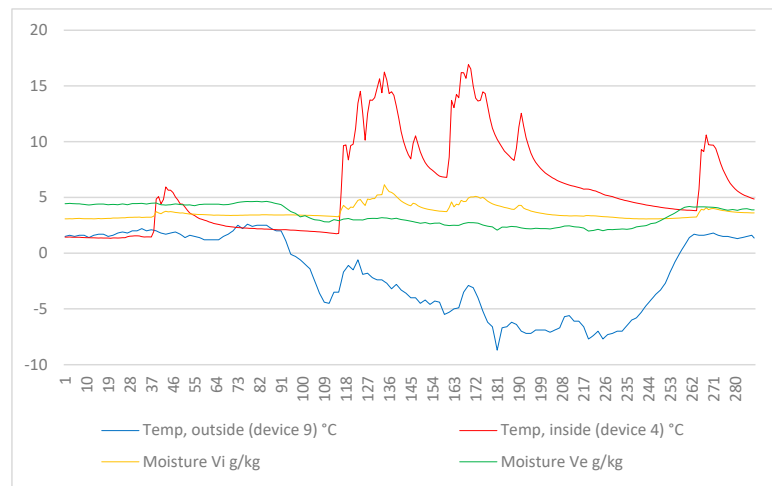
**Figure 14.** Outdoor and indoor humidity and temperature in the Krimulda Church “on the balcony”.

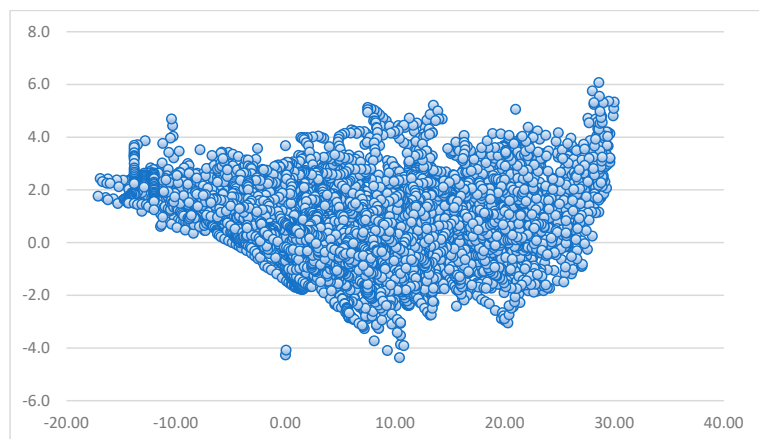
**Figure 15.** Excess moisture in the Krimulda Church on the balcony.

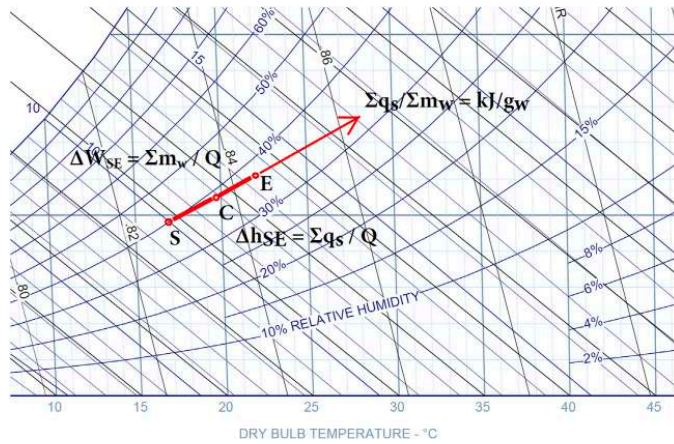
FIGURE 1 Principle of reference line on ASHRAE psychrometric chart protractor, where the angular coefficient of changes in air condition is in units of kJ/g<sub>w</sub>.

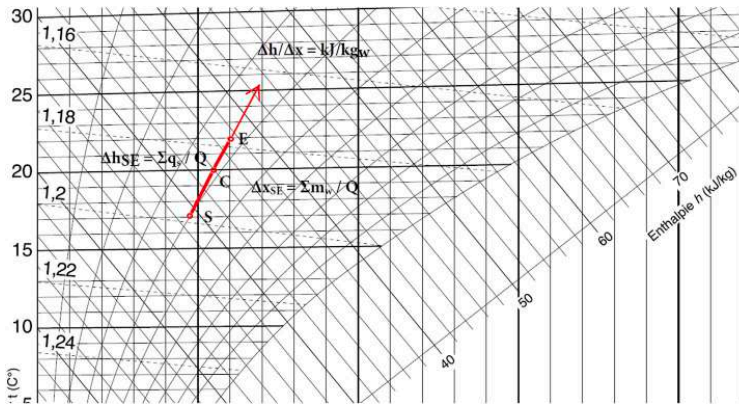
FIGURE 2 Angular coefficient of process change of air parameters on Mollier diagram, where  $\Delta h/\Delta x$  is in units of kJ/kg<sub>w</sub>.

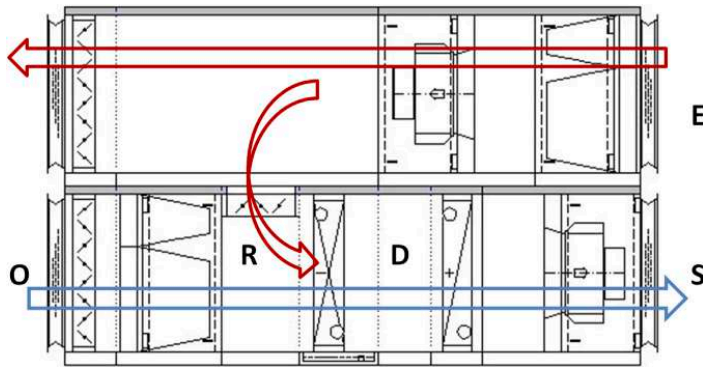
FIGURE 4  
Air handling unit 1 (E—exhaust air; O—fresh incoming air; R—air post-recirculation; D—air post-cooling and dehumidification; S—supply air).

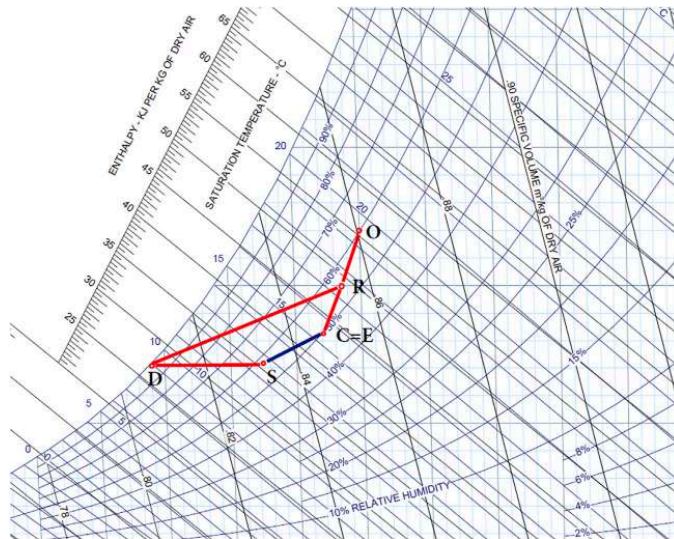
FIGURE 5  
Schematic of air conditioning process on a psychrometric chart, illustrating a design concept utilizing recirculation.

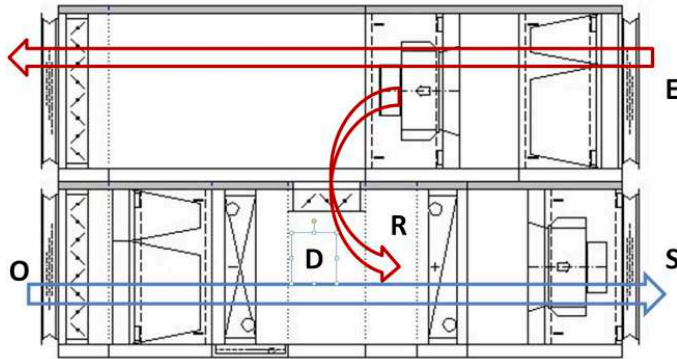
**FIGURE 6**  
Air handling unit 2 (E—exhaust air from room; O—incoming fresh outside air; D—air after cooling and dehumidification; R—air post-recirculation of outgoing air; S—supply air). After the cooling and drying process of fresh air, the recirculation is facilitated by combining the cooled and dried air (point D) with the exhaust air (point E).

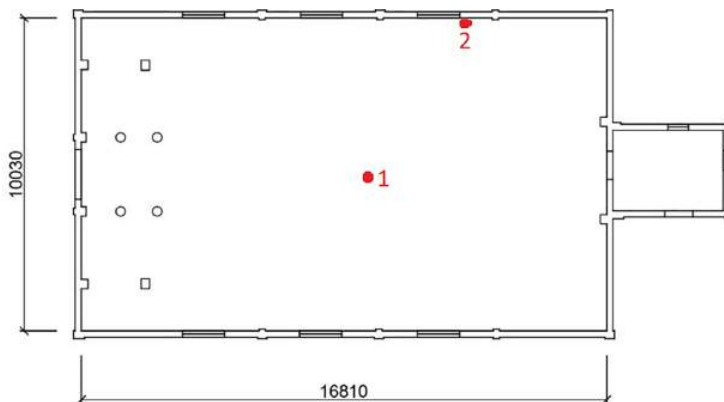
Fig. 4. Layout of the Turaida Church with the installed measuring devices.

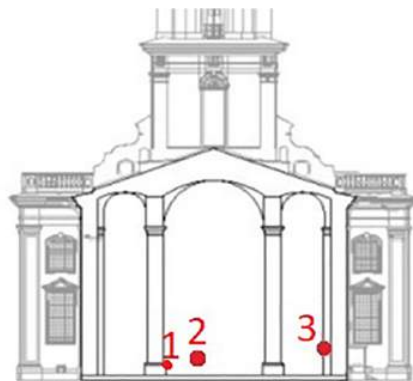
Fig. 7. Cross-section of the Liepaja St. Trinity Cathedral with the installed measuring devices.

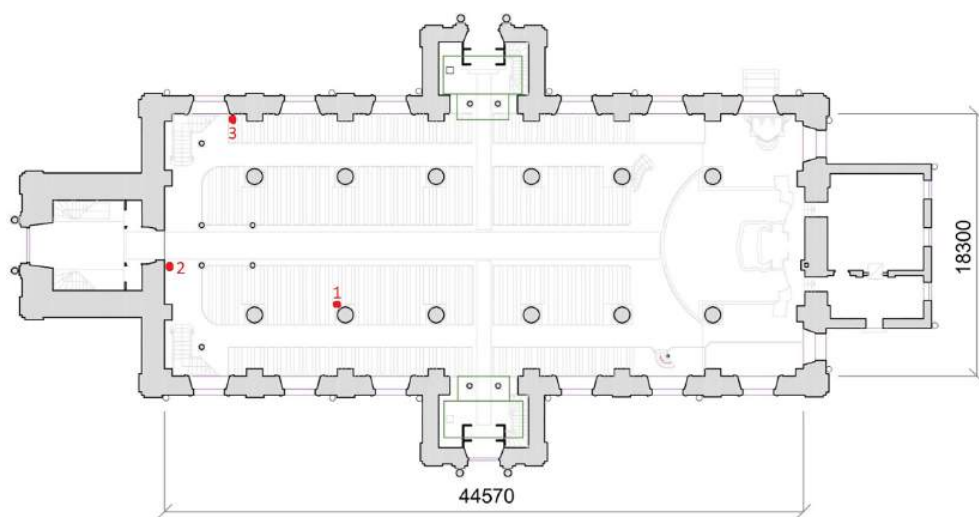
Fig. 6. Layout of the Liepaja St. Trinity Cathedral with the installed measuring devices.

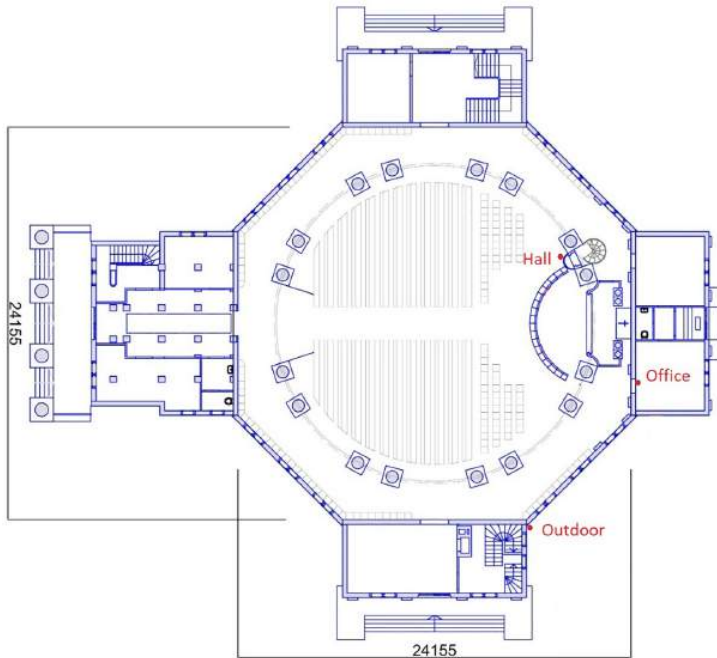
Fig. 8. Layout of the Riga Jesus Church c.

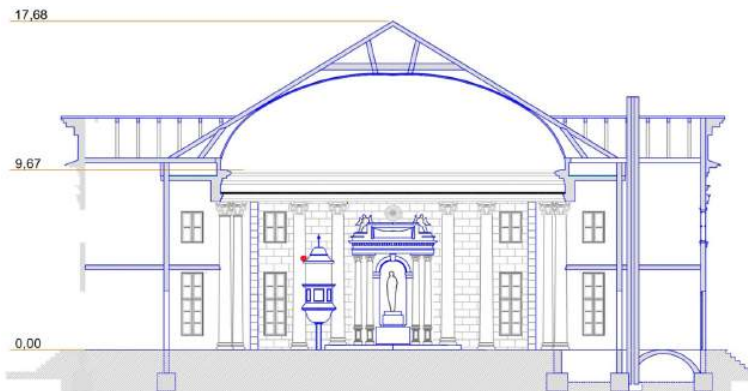
Fig. 9. Cross-section of the Riga Jesus Church with the installed measuring devices.

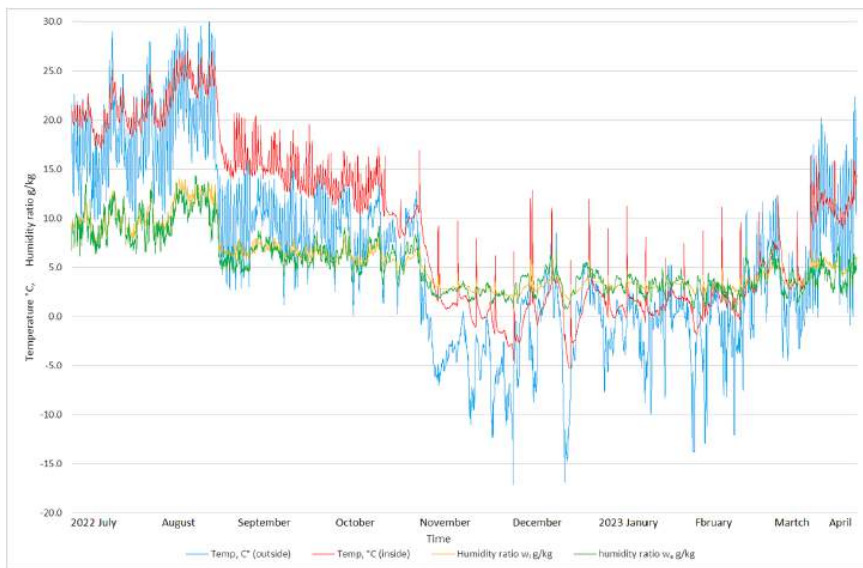
Fig. 11. Outdoor and inside moisture and temperature in the Turaida Church on the lamp.

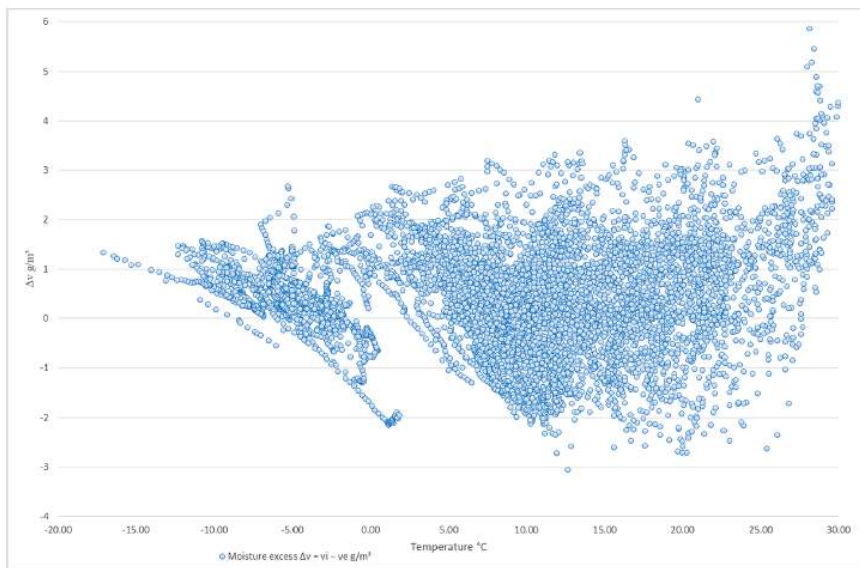
Fig. 12. Excess moisture in the Turaida Church on the lamp.

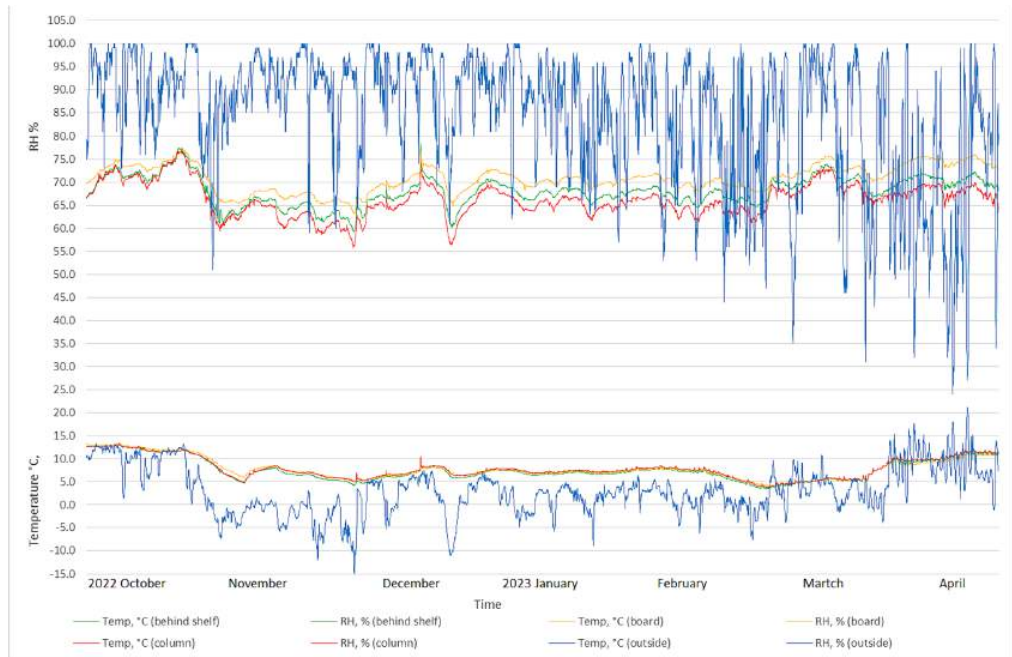
**Fig. 13.** RH and temperature in Liepaja St. Trinity Cathedral.

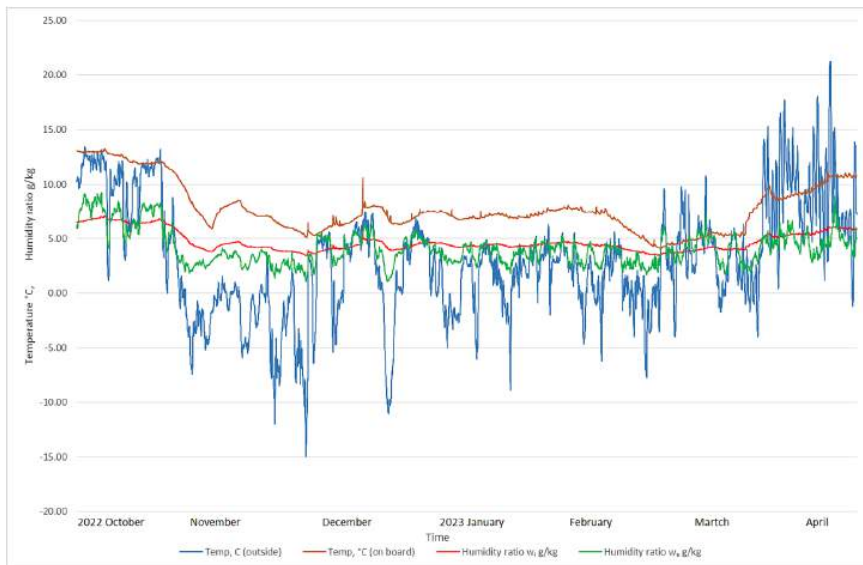
Fig. 14. Outdoor and inside moisture and temperature in Liepaja St. Trinity Cathedral on the column.

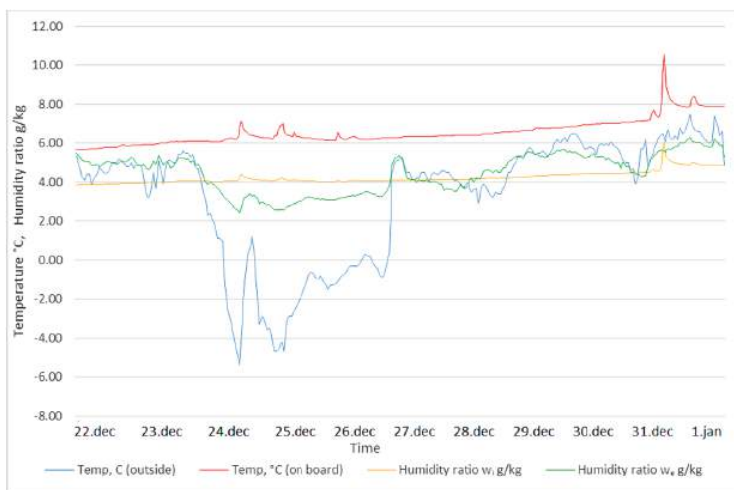
Fig. 15. Outdoor and inside moisture and temperature in Liepaja St. Trinity Cathedral on the board between 12/22/2022 and 01/02/2023.

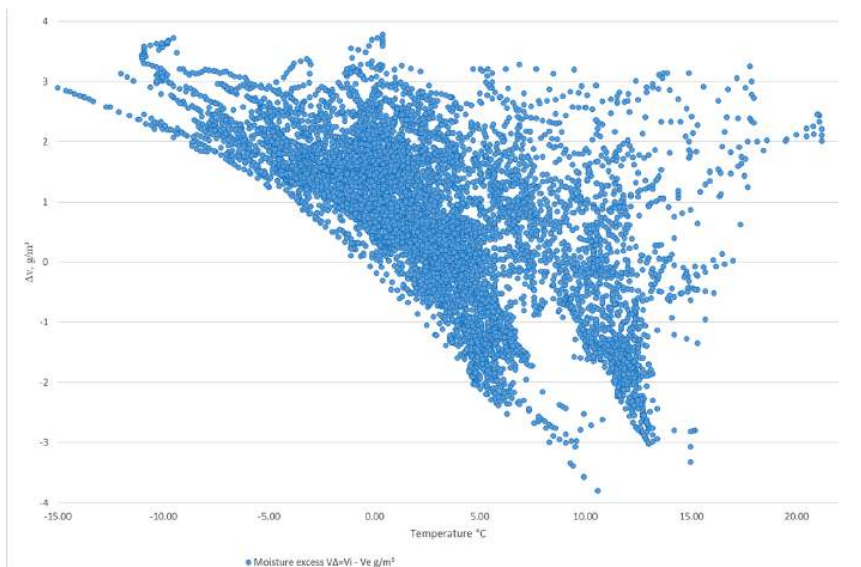
Fig. 16. Excess moisture in Liepaja St. Trinity Cathedral on the board.

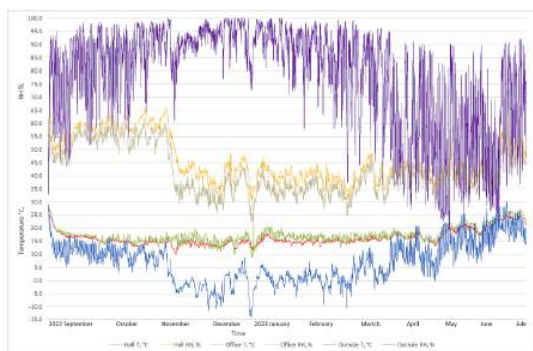
Fig. 17. RH and temperature in Riga Jesus Church in the hall.

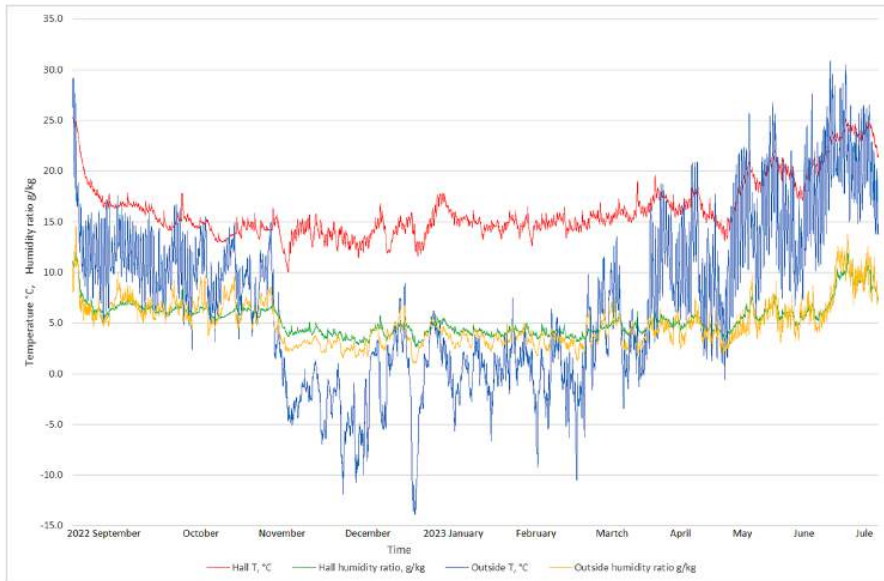
Fig. 18. Outdoor and inside moisture and temperature in Riga Jesus Church in the hall.

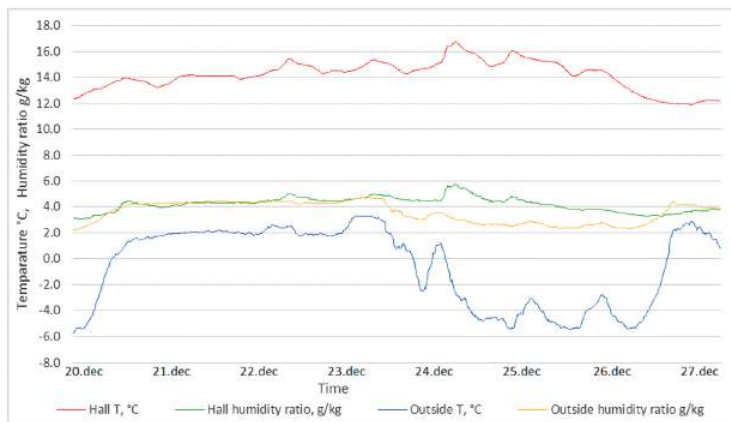
Fig. 19. Outdoor and inside humidity ratio and temperature in Riga Jesus Church in the hall between 12/20/2022 and 12/28/2022.

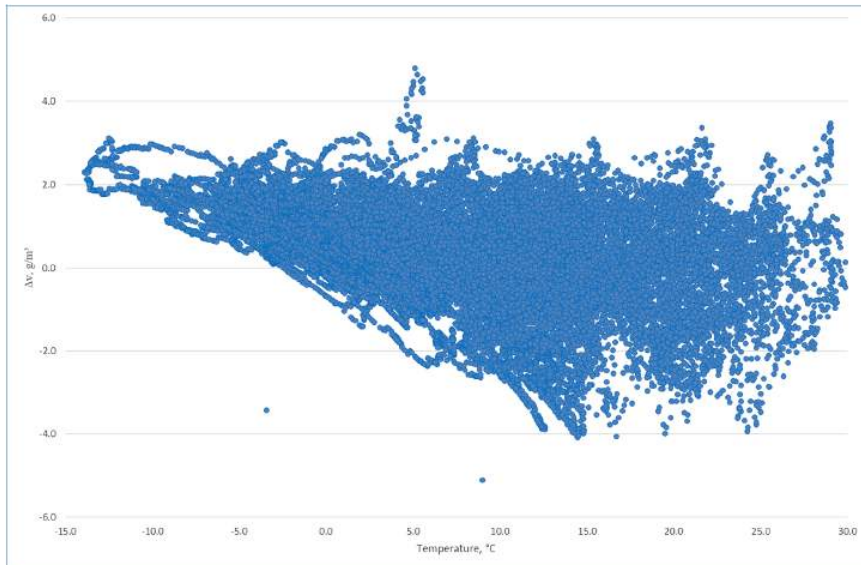
Fig. 20. Excess moisture in Riga Jesus Church in the hall.
