RIGA TECHNICAL
UNIVERSITY

ANALYSIS OF THE IMPACT OF RAIL GRINDING ON THEIR CONDITION

Summary of the Doctoral Thesis

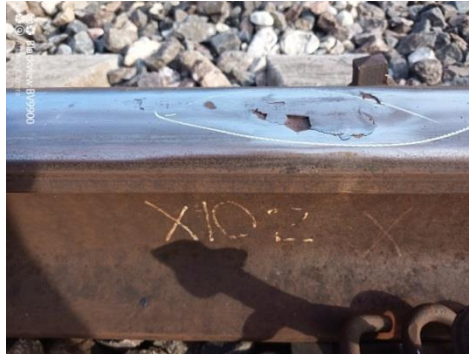
Fig. 2.2. A defect found in rail road section Menta–Daudzeva 256 km 6 pk.

Pitting of metal and delamination cracks on the running surface with code X 10.1-2 usually occur due to violation of rail production technology (closed rolling, small cracks, peeling, etc.) [2]. Such defects can be easily seen in visual inspection, see Fig. 2.2.

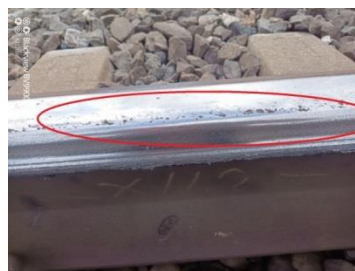
Fig. 2.3. A defect found in curve $R = 708$ m in Vecumnieki station 1, on the main road.

Flaws in metallurgical quality of rail steel (accumulation of local non-metallic inclusions, stretched along the direction of rolling) determine the insufficient contact fatigue strength. Most often the work edge of outer threads in rail road curve stations ($R = 400\text{--}1000$ m) are damaged, see Fig. 2.3. Pitting begins with the formation of inner longitudinal cracks of contact fatigue and development in the work cut-out zone of the real head. Contact fatigue cracks can also develop from rolling stock on the middle part of the rail head, gradually reaching under the rolling stock and creating elongated horizontal contact fatigue cracks. Usually, the defect is created on the outer rail work edge in the form of cut-out curves with a small radius, it can be accompanied by side wear. In some cases, a longitudinal crack can appear due to shallow upper contact fatigue cracks that are parallel and can develop even deeper [23].

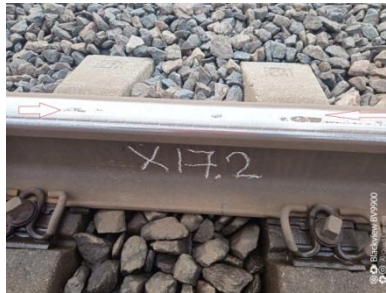
Fig. 2.4. Pitting on rail head surface in Vecumnieki station.

If the technology of rail hardening is not followed properly, zones of martensite or zones of local uneven hardness transition from the hardened to the unhardened metal layer can form in the hardened layer. During operation, metal delamination and pitting can occur in these zones due to the effect of the rolling stock, see Fig. 2.4. The acceleration of the defect appearance is stimulated by the curvature of the rail ends.

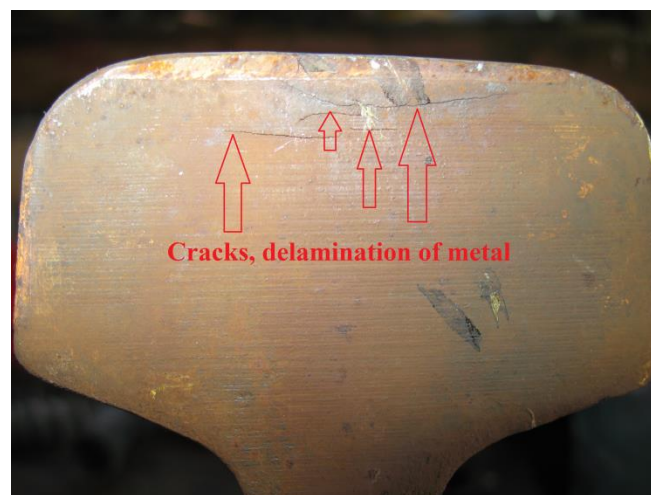
Fig. 3.5. Defect with code X10.1 found in railroad section Vecumnieki–Lāčplēsis.

One of the most popular defects in “Latvijas dzelzceļš” network is the defect with code X 10.1-2. This defect includes metal cracks and pitting on the running surface of head due to non-compliance with the manufacturing technology (closed rolling, small cracks, peeling, etc.) [2], see Fig. 3.5. The defect location designation with a number (third number in the defect code) is assumed as follows:

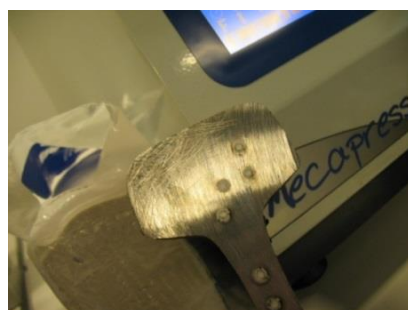
Fig. 3.8. Determination of chemical composition using chemical analyser PMI-Master PRO.

Further, using chemical analyser PMI-Master PRO, see Fig. 3.8, a full chemical composition for steel rail R350HT was found [7]. The results of the chemical composition are presented in Table 3.3.

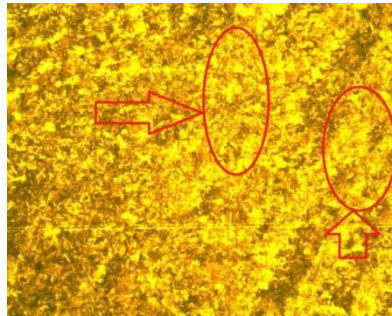
Fig. 3.12. Microstructure of defect X10.1 with 200× zoom.

The microstructure of steel R350HT is of ferrite-perlite, in Fig. 3.12 it can be seen with a large collection of perlite (marked with red arrows) that takes up more than half of the total amount. The increased oxygen content of more than 0.039 % proves it.

The rail micro structure is discussed further. Using 5 % nitric acid solution HNO_3 , a defect sample etching was performed [17]. Afterwards, this sample was examined under a microscope with 200× zoom, see Fig. 3.12.

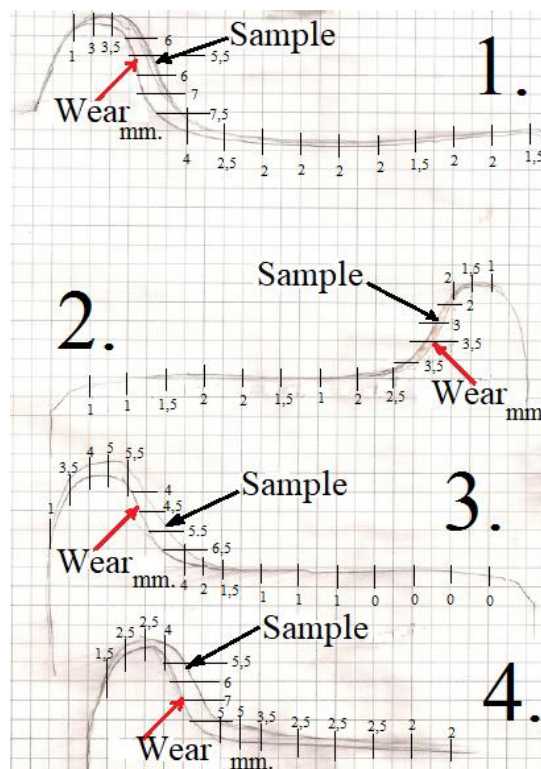
Fig. 5.2. Characteristic wear of freight wagon wheelset rims (1, 2, 3, 4) in “Latvijas dzelzceļš” network.

Fig. 5.2 shows that the heaviest wear of the wheelset rim is on the flange part of the first rim – it is 7.50 mm. However, the wear on the second rim is 3.50 mm. The wear of flange part on the third and fourth rim fluctuates from 7 mm to 550 mm. Wear on the wheel rim is located in zone 1–3.50 mm. Based on the research performed at this stage, it can be said that the wear of the rim of the wheelset of freight wagons is topical in “Latvijas dzelzceļš” network. This is also confirmed by the defect statistics of the sharp-edged rim wheelset and the thin rim.

After the representation was made, the wear of the wheelset rims of the freight trains were measured and the most common ones in this network of “Latvijas dzelzceļš” were selected. In scale M 1:1 wheelset rim wears were drawn with distribution of freight wagon wheel wear by points (Fig. 5.2).

According to the gathered data on the wear of wheel (Fig. 5.2) and rail (Fig. 5.3), their contact interaction will be researched from a geometric point of view. A 3D modelling of wheel GOST-10791 [20] and rail 60 E1 [4] will be performed in SolidWorks program. The contact form assessment was modelled for new and worn-out rails in various combinations with wheels. The most dangerous contact types subject to further stress assessment are shown in Fig. 5.9 in straight rail road sections and accordingly curved sections with an 800 meter radius.

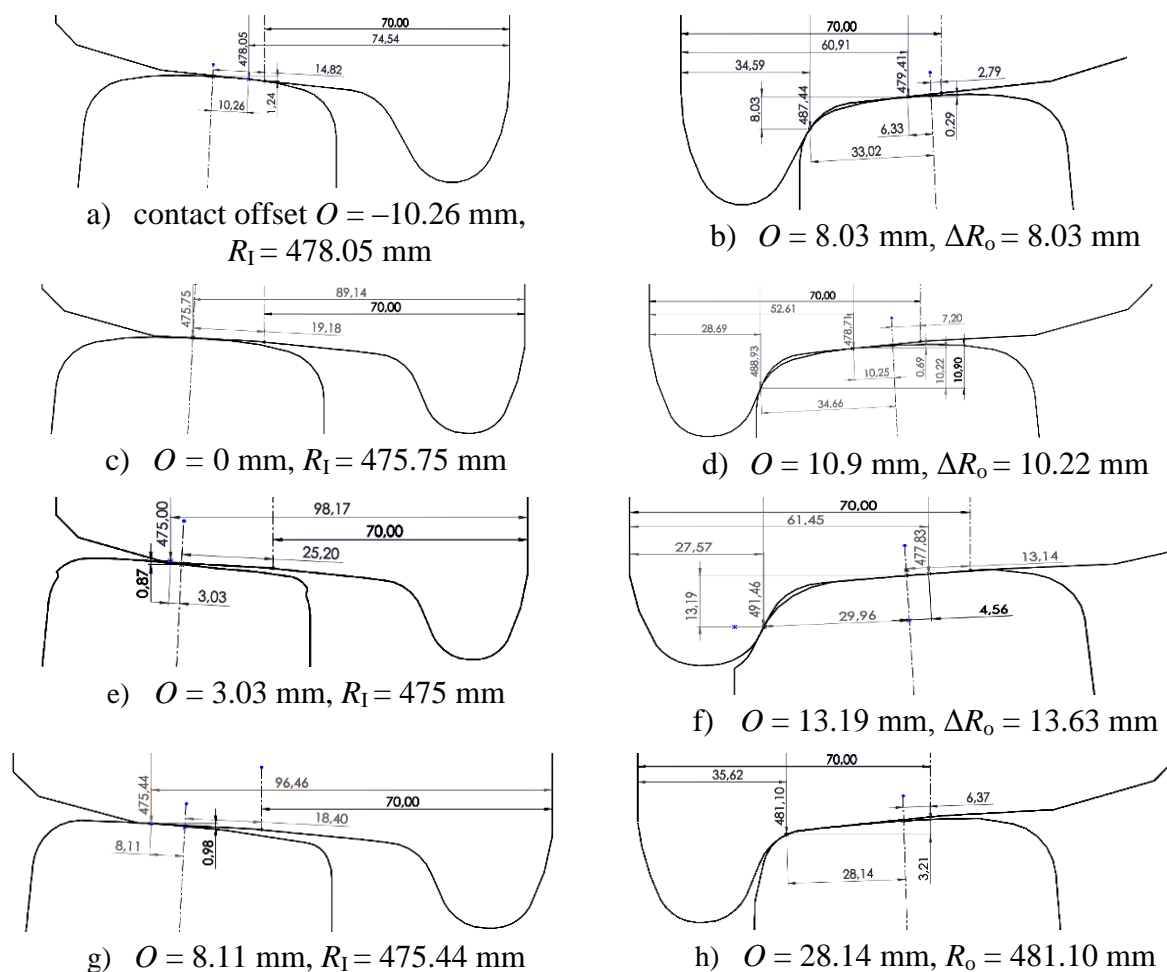
The results of geometric modelling of variants revealed that in straight rail road sections there the contact is predominantly in the middle area of wheel and rail, which does not cause edge wear – single point contact. Thus, according to the results of the location zone of the interaction between the wheel and rail contact surfaces, asymmetrical profiles for rail grinding have been developed for tracks with a radius of 800 meters, taking into account the profile of the wheel, which has a characteristic wear in “Latvijas dzelzceļš” network.

Fig. 5.9. Contact types of interaction of 60 E1 type rail and wheel GOST-10791 profiles: a), b) new rail (grinded rail by new) and new wheel; c), d) side wear of 6.50 mm of new rail and wheel; e), f) vertical wear of inner rail – 2.50 mm, side wear of outer rail – 6 mm, vertical – 1.50 mm, and wheel wear – 6.50 mm; g), h) developed rail grinding profile with wheel wear 6.50 mm; a), c), e), g) R_1 – the radius of the wheel in contact with the inner edge of the rail; b), d), f), h) ΔR_0 – wheel radius deviation at two contacts of the outer rail profile.

The evaluation of the influence of different rail grinding profiles on the pair wheel-rail friction interaction confirmed the efficiency of rail grinding profiles Figs. 5.9 g, h. The wheel-rail contact area is shifted to the track curve centre, wherein the displacement of the inner rail is 5 mm to 18 mm and the wheel radius is reduced by 0.44–2.60 mm, but on the outer rail from 18 mm to 32 mm, and the wheel radius increases from 1.69 mm up to 3.27 mm. The difference between the inner and outer radius of the wheel for the profiles used varies from 1.36 mm to 2.96 mm, but the highest value of 5.66 mm is reached for the rail profiles developed in this work [9]. The increase in the radius difference allows to improve the inclusion of the wheelset 4 times, and the single-point contact does not affect the edge area in the modelled curves with a radius of 800 m.

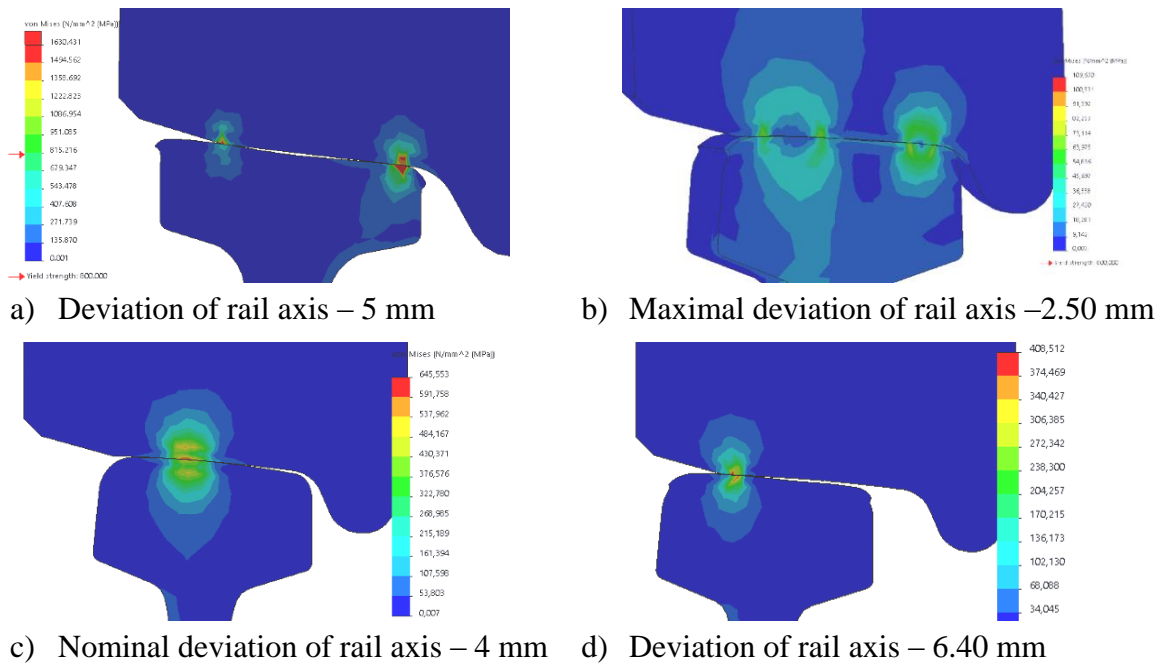
Fig. 5.11. Von Mises stress of worn-out wheel on rail profiles in “Latvijas dzelzceļš” network: in straight rail road sections: a) maximal wear of rail profile; b) wear of rail 2.50 mm; c) calculation profile of rail in Fig. 5.10 a; inner rail in curve d) designed rail profile in Fig. 5.10.

On straight rail roads, during the interaction of profiles of the worn-out wheel and rails, the stress level of 1630 MPa exceeds the limit of material flow ability, see Fig. 5.11. Using the developed rail profile shown in Fig. 5.10a), the stress reduced to 640 MPa. The stress level on the outer rail during the wheel and rail interaction on curved rail roads was 1770 MPa in one-point contact, and 620 MPa in the two-point contact (Figs.5.12 a, b). After the corrective grinding of rail, the stresses reduced to 510 MPa in the work radius zone (Figs. 5.12 c, d). In the outer rail, the stresses reach 450 MPa (Fig. 5.11 d), using the developed rail profile (Fig. 5.10 c).

Taking into consideration the results of geometric modelling of contact zone, wheel and rail contact stress will be calculated in straight rail road parts and curves with a radius of 800 m. 60 E1 type rails with new profile, worn-out and newly modelled asymmetric rail repair (grinding) profile, as shown in Fig. 5.10, was chosen. Wheel GOST-10791 [24] with the characteristic wear of “Latvijas dzelzceļš” network, as in Fig. 5.2 (3), was chosen. The results of calculations are shown in Figs. 5.11 and 5.12.

As shown in Fig. 5.11 c, the use of the developed rail (Figs. 5.10 a, c) will allow on rail road to shift the contact area from the outside of the rail road on a straight line to an area with less wheel and rail wear (Figs. 5.2(3) and 5.11 a). This solution will stimulate more even wear of the rail and wheel profiles. As shown in Fig. 5.12 d, the usage of the developed profile (Fig. 5.10 b) and the corrective grinding for profile (Fig. 5.12 c) will allow the outer rails with the contact area of the wheel flange surfaces to be excluded in the curves. Performing grinding along these profiles, a one-point contact can have a larger area than the usable rail grinding profiles. A two-point contact development is possible as well, as can be seen from the example in Fig. 5.12 b, with minimal gaps of 1.00–1.20 mm in the flange base radius zone. After working on the outer rail and wheel surface, the profiles of rails and wheel will have a conformal state with gaps of 0.40–0.60 mm by the flange base.

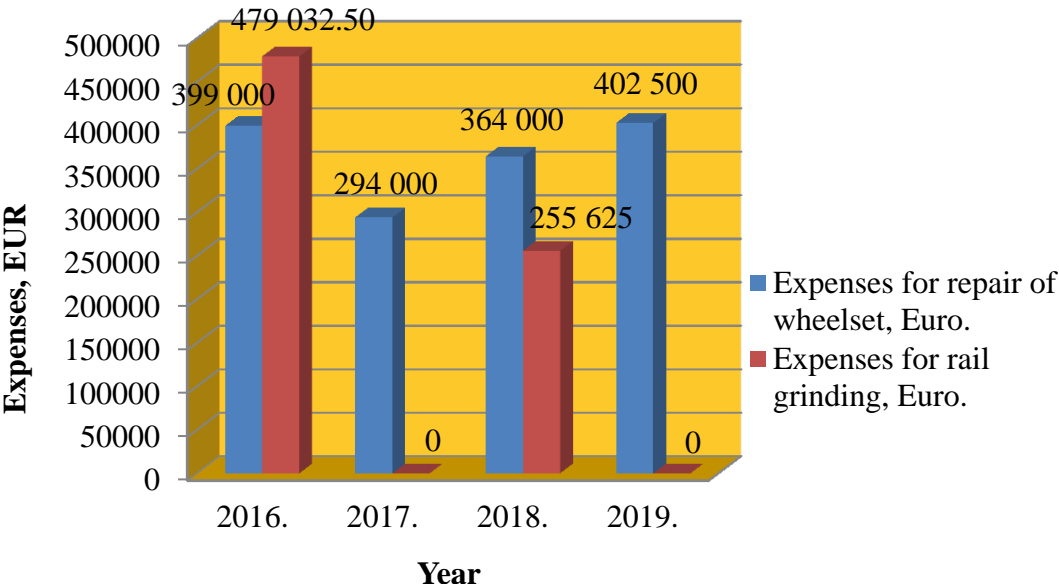
Fig. 5.13. Economic expenses for wheelset defect repair and rail grinding.

As shown in Fig. 5.13, in 2016, “Latvijas dzelzceļš” spent EUR 399 000 for the repair of wheel pair defects, while EUR 479 032.50 were spent for rail grinding. In 2017, the expenses

According to the accounting data of the repair shops, at the technical maintenance points (TMP) of rolling stock, the price of one pair of wheelsets in a set is EUR 2500–2700. By contrast, the price of a new or by a repair company repaired wheelset is EUR 3100–3200 (including rolling, dismantling, turning, full audit, assembly, tightening). According to the statistical data regarding the wheelset defects (Fig. 4.1) sharp edged on-welding and thin flanges are the main defects in the interaction of wheel and rail in “Latvijas dzelzceļš” network. The number of these defects will be summed up when drawing up the economic graph. For economic comparison, we will show the statistics of grinded rails and exposed sharp-edged on-welding and thin flange defects in the period of 2016–2019. For this purpose, a graph will be created in Microsoft Excel (Fig. 5.13).
